1/3rd Scale Mita Type 3 Production Notes

The fifth part of a multi-part series.

Fabrication Part 16: Elevator Control System

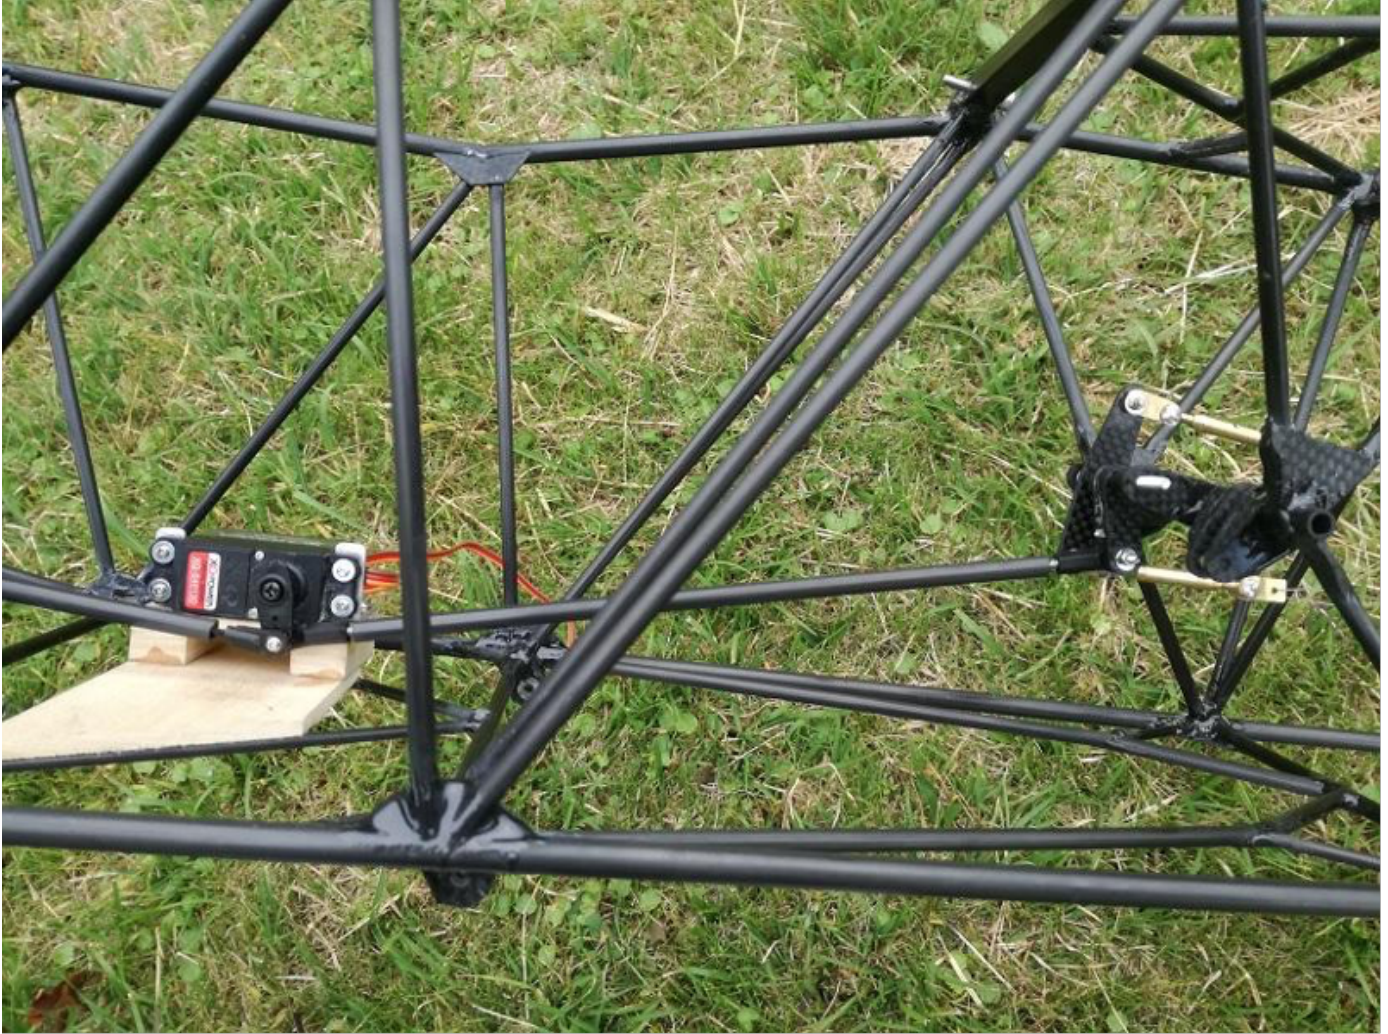
Photo 88: Elevator servo and front side bellcrank.

Now that the gimbal mechanisms have been modified, the elevator control system has been installed. Photo 88 shows the connection between the elevator servo and the front side bellcrank.

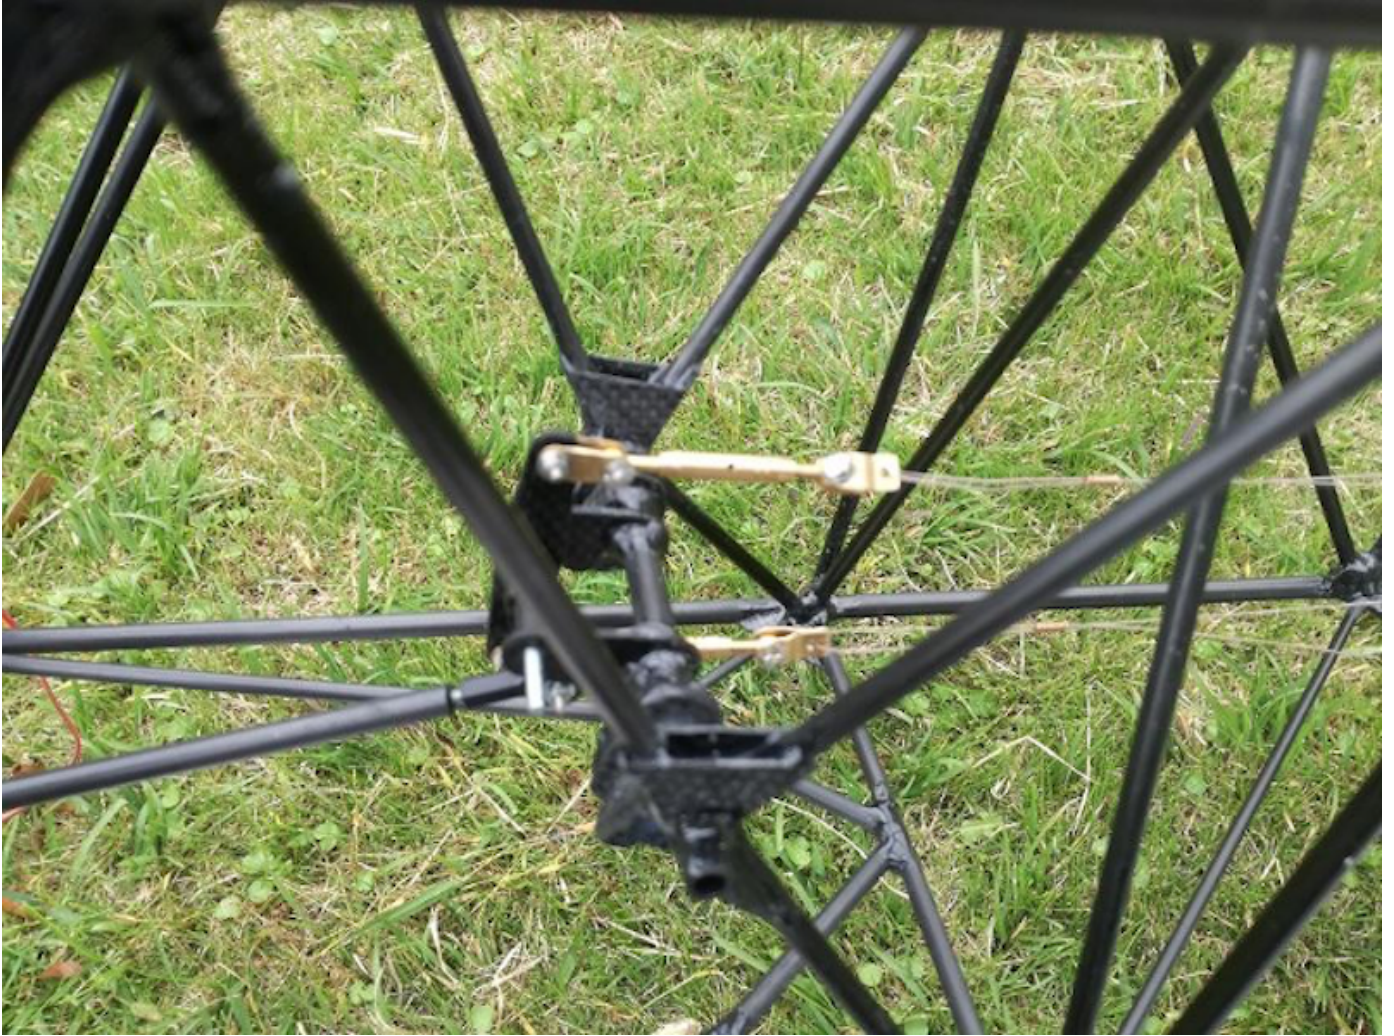
Photo 89: Enlarged view of the front bellcrank.

Next, photo 89 is an enlarged photo of the front side bellcrank. The picture is out of focus, but you can see two turnbuckles on the bellcrank to adjust the wire tension. The turnbuckles were made from a $\Phi 5$ brass rod by Mr. Takamura who has a mini-lathe.

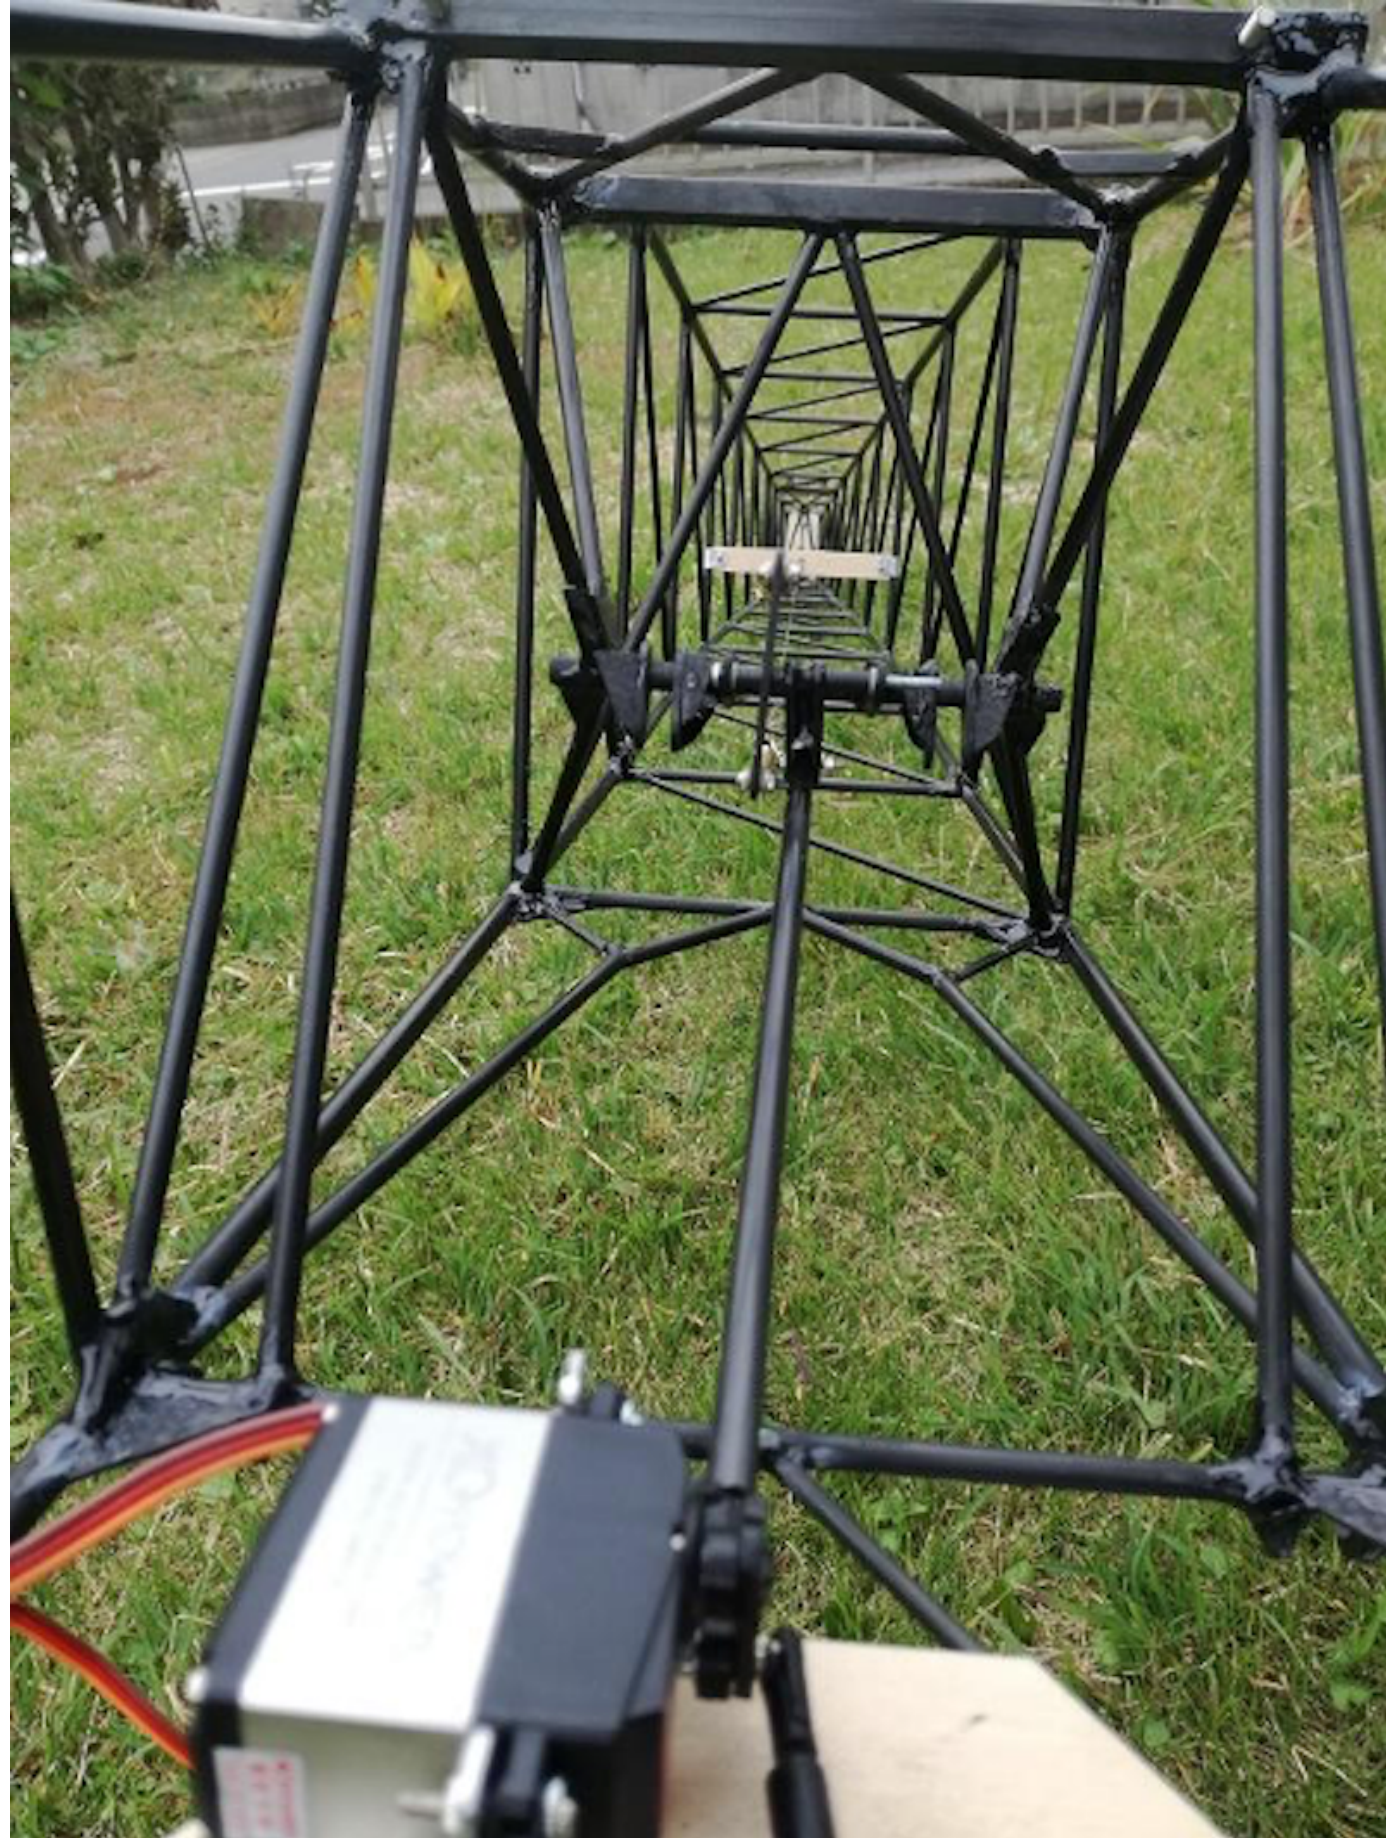
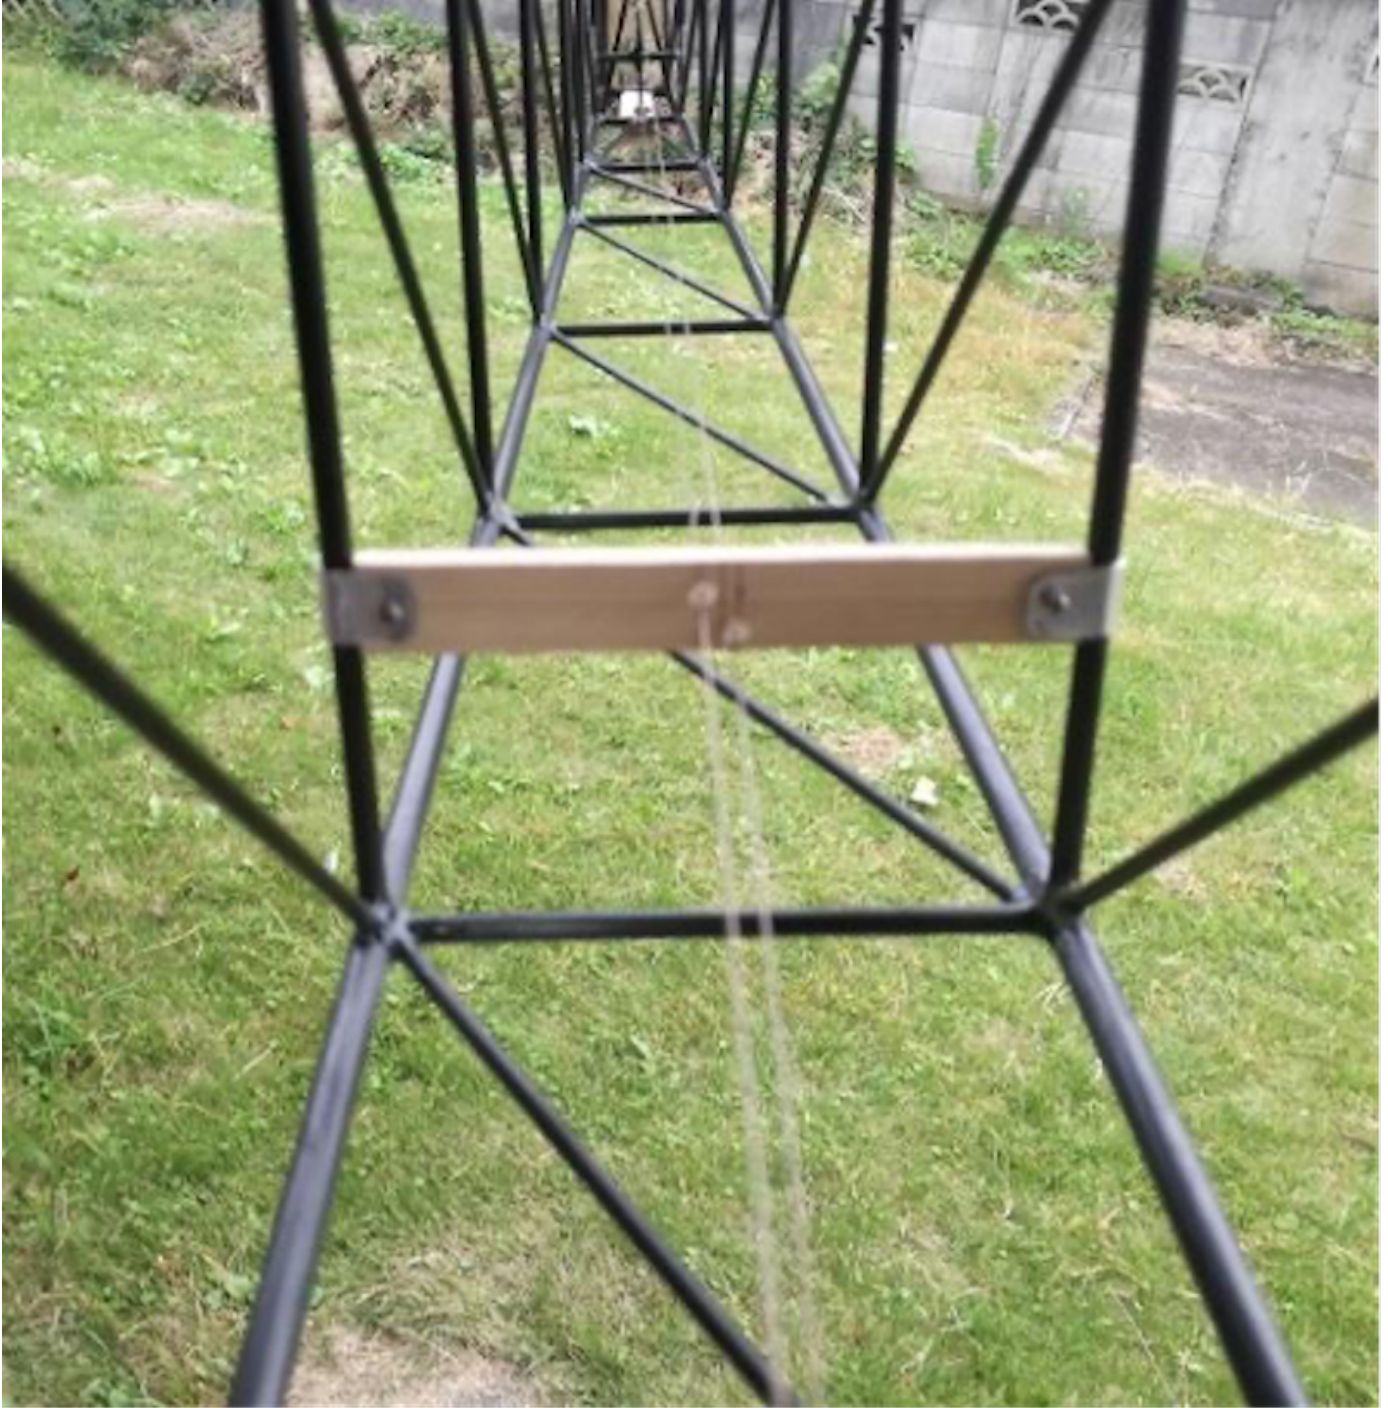
Photo 90: Left, rearward view of the inside of the fuselage. Right, looking backward inside the fuselage.

A wooden stay is attached in the middle of the rear fuselage to avoid the crossed wires from rubbing against each other and to prevent the wires from vibrating.

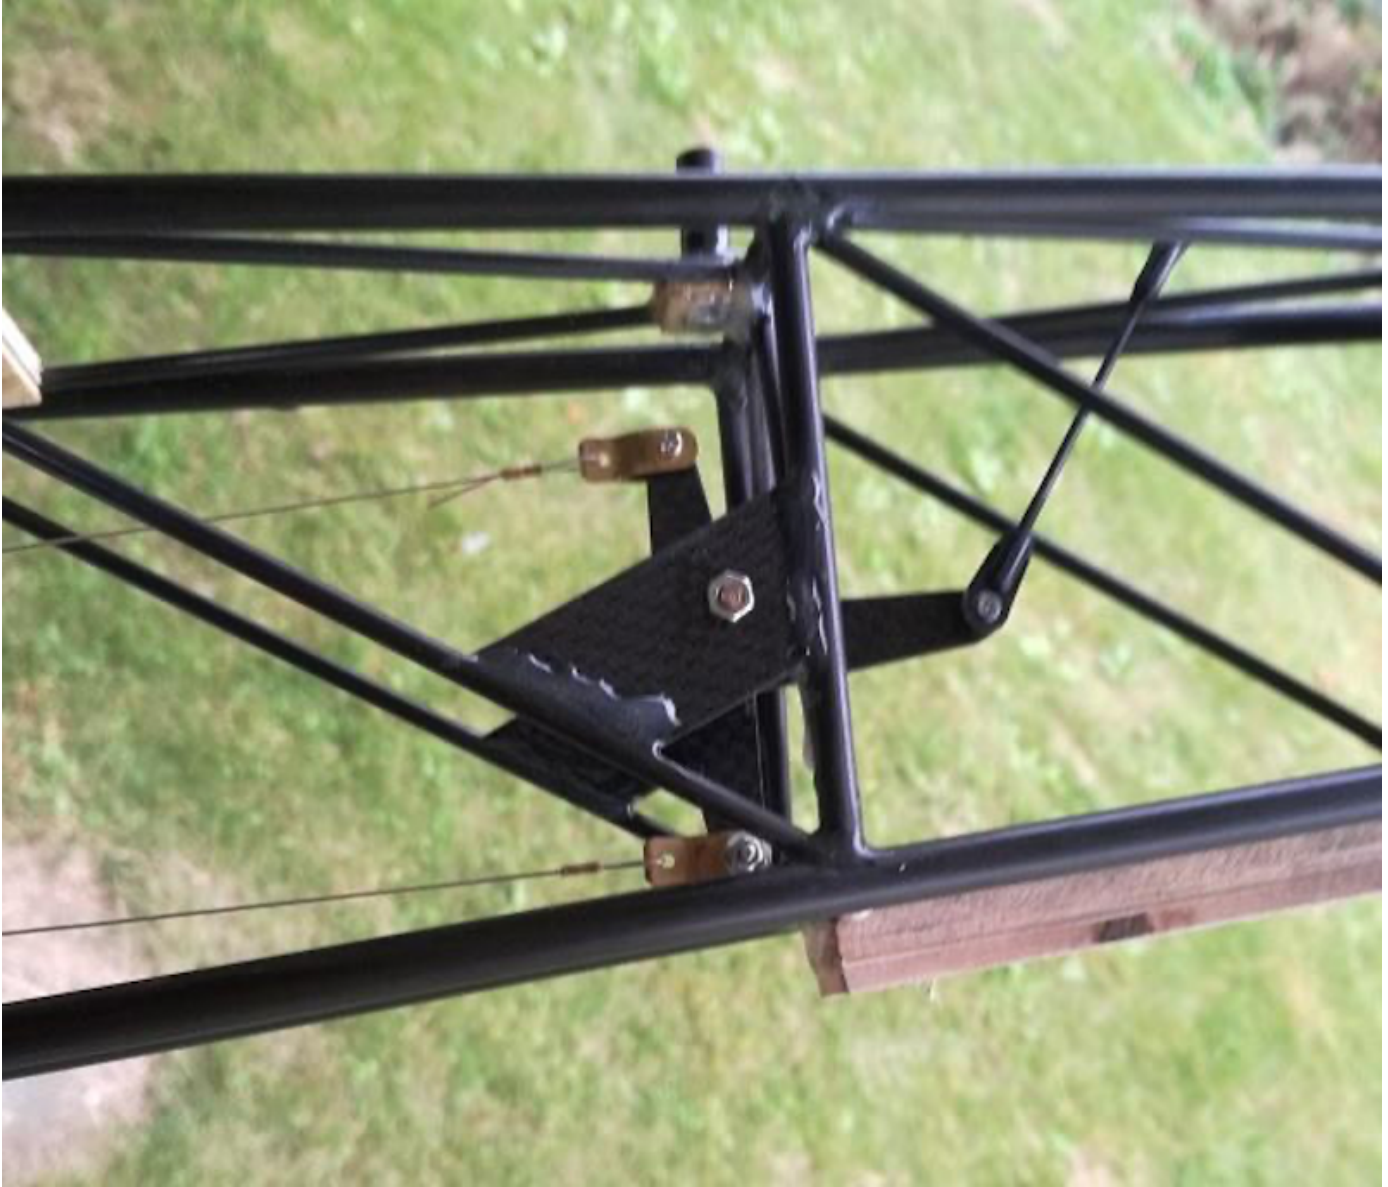
Photo 91: The rear bellcrank.

The wires are still temporarily fastened.

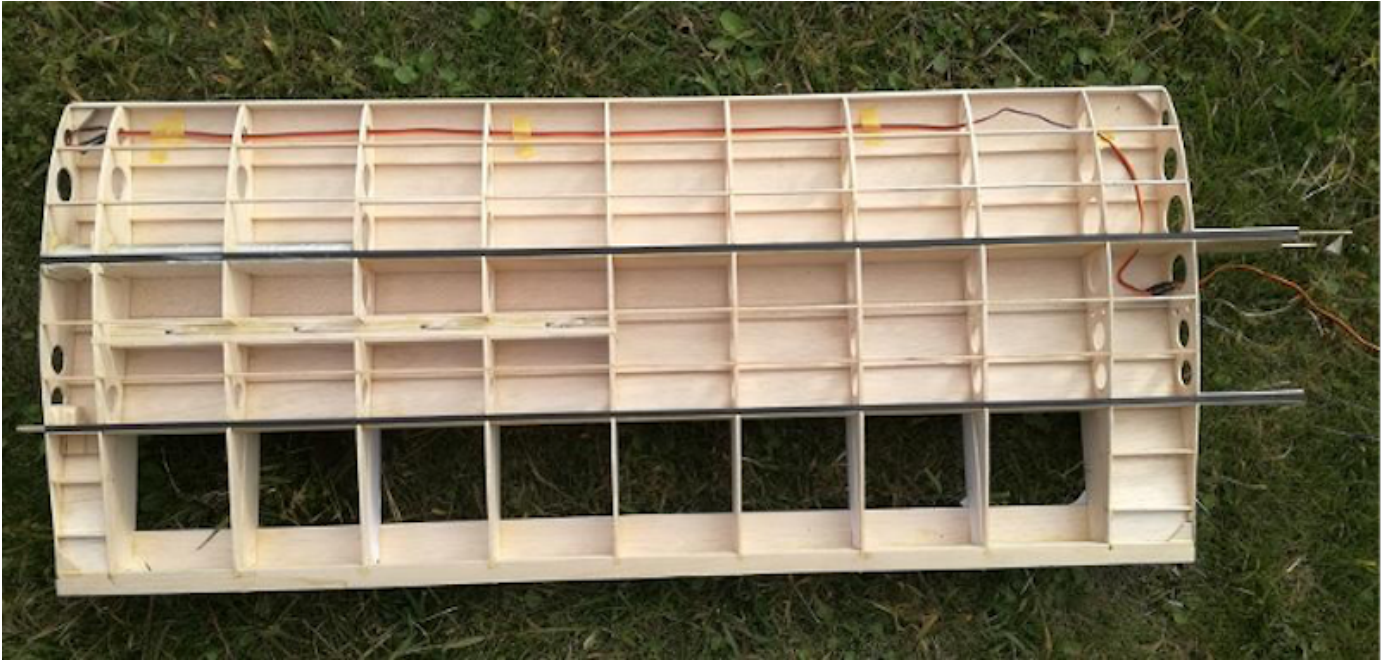
Photo 92: Left side center wing with the lower plank completed.

out the spoiler part from the inside and the extension cord is inserted for the aileron servo. I set the cord near the leading edge to avoid any tail-heaviness. Photo 92 shows the left center wing with the lower plank completed.

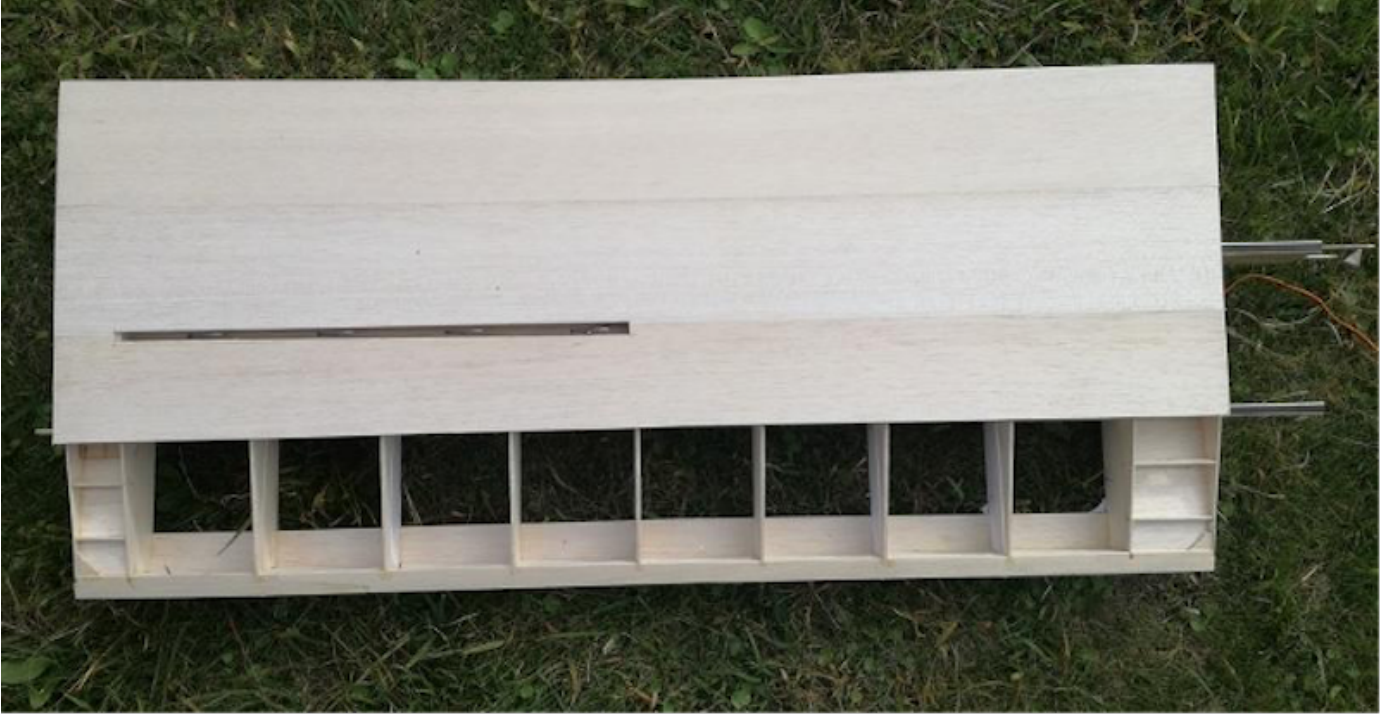
Image 93: Aligning the upper plank material.

Next is the upper side plank. The upper spoiler groove cannot be cut out from the inside after planking, so carefully align and cut it out beforehand.

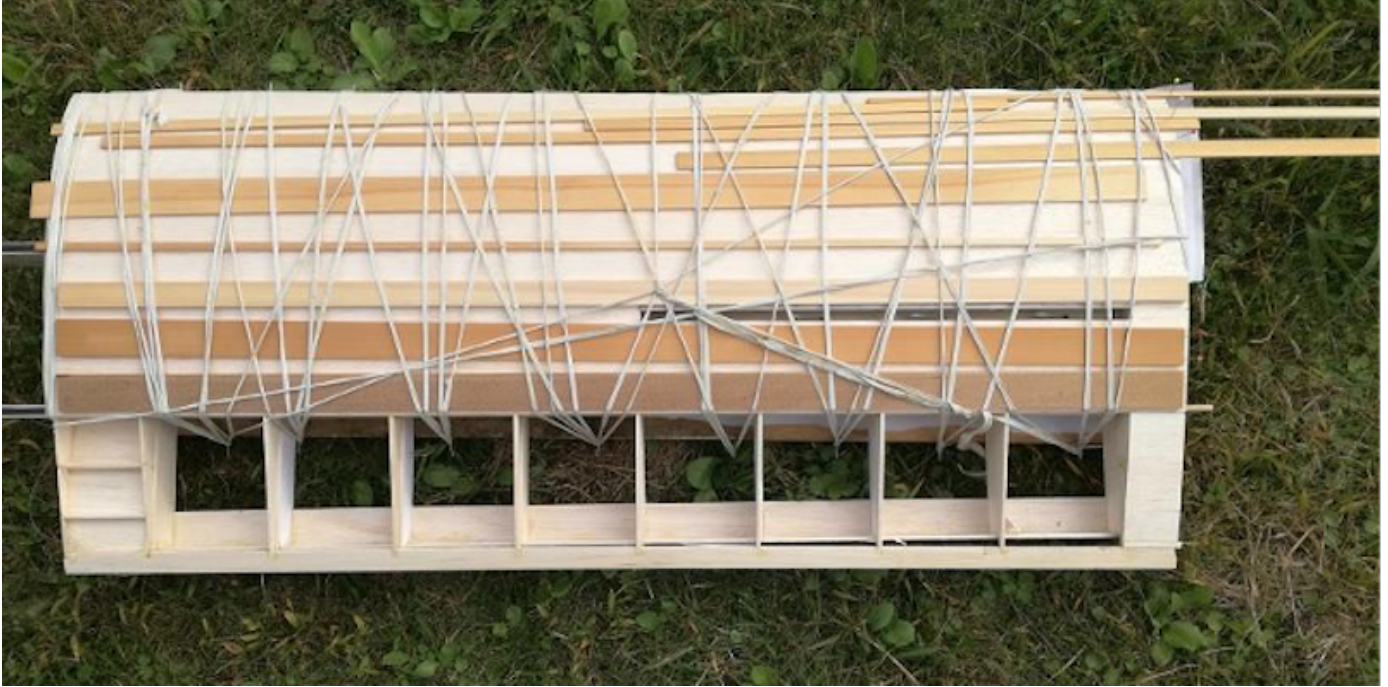
Image 94: Upper plank of the center wing.

The next step is to place the wing on an assembly jig placed on a thick plate, and apply titebond to the ribs, spars, and stringers. The upper plank is inaccessible from the back, so instant adhesives cannot be used. After making sure that there is no residue of the titebond, the plank material is carefully positioned and then covered. Next, cover the plank with a few thin cypress sticks, hook the rubber band to the nails on the side of the base plate, and press down the entire assembly onto the jig.

This is to make sure that the plank material adheres to the ribs and spars. When the glue dried, thin 15 mm wide bars were cut from a 4 mm thick balsa board and attached to the front edge. Then, I sanded and shaped the leading edge.

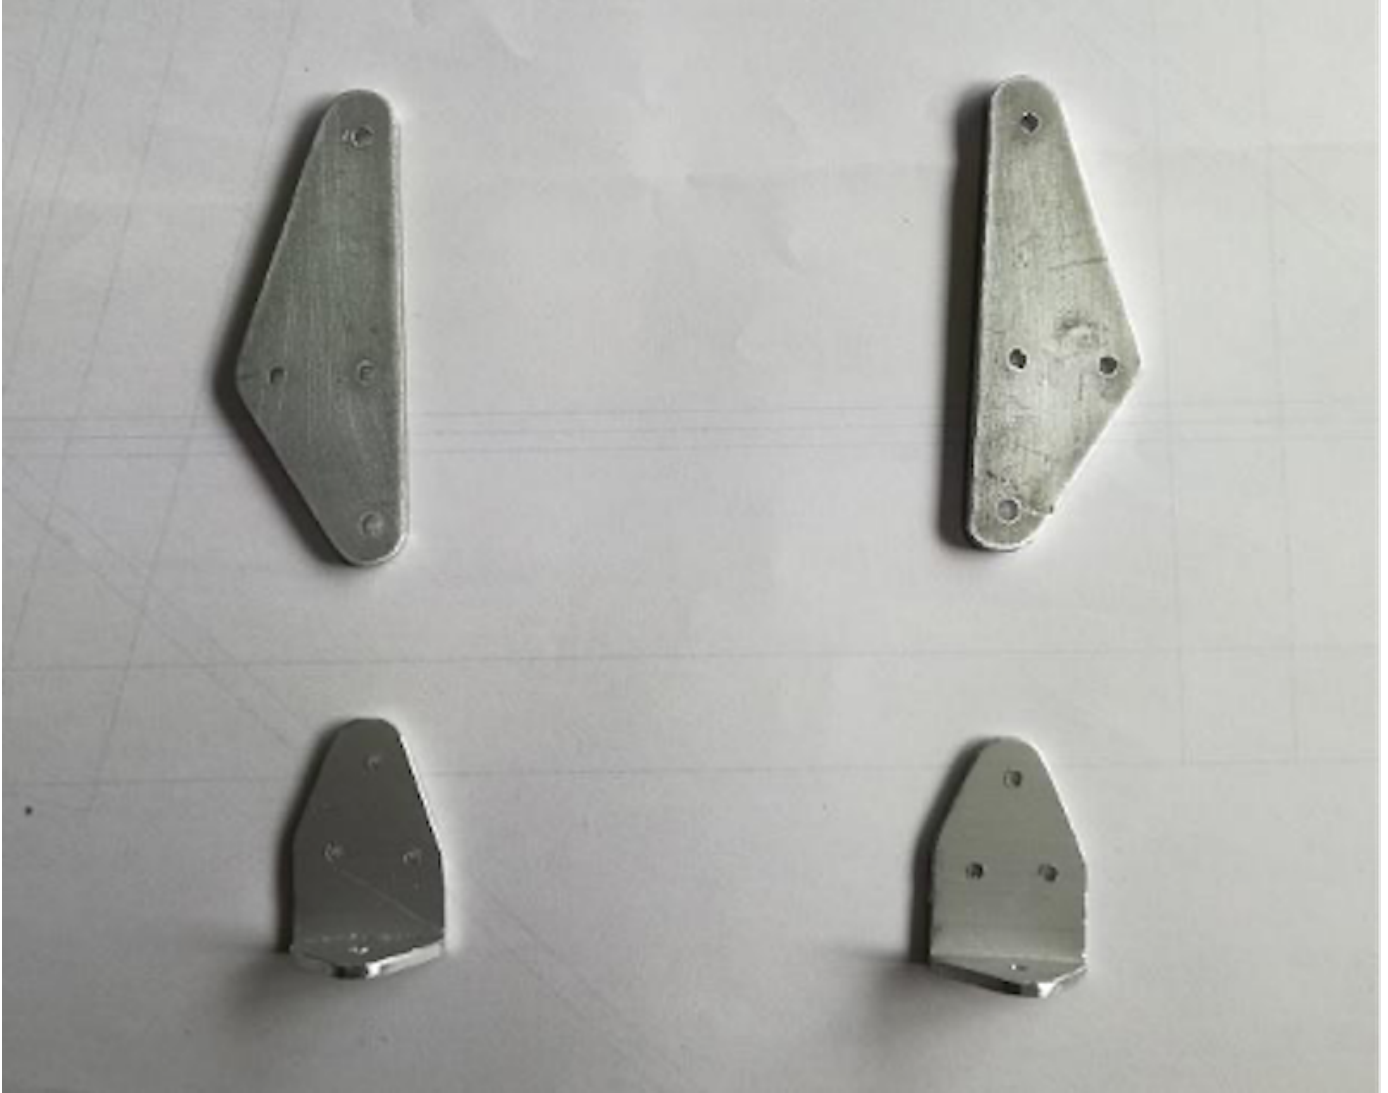
Photo 96: Wing fuselage joint fittings: top, front side; bottom, rear side.

The front fittings were cut from 3mm thick hard aluminum that was used for the main landing gear of a discarded RC fixed wing, and the rear fittings were cut from 2mm thick L-shaped channel.

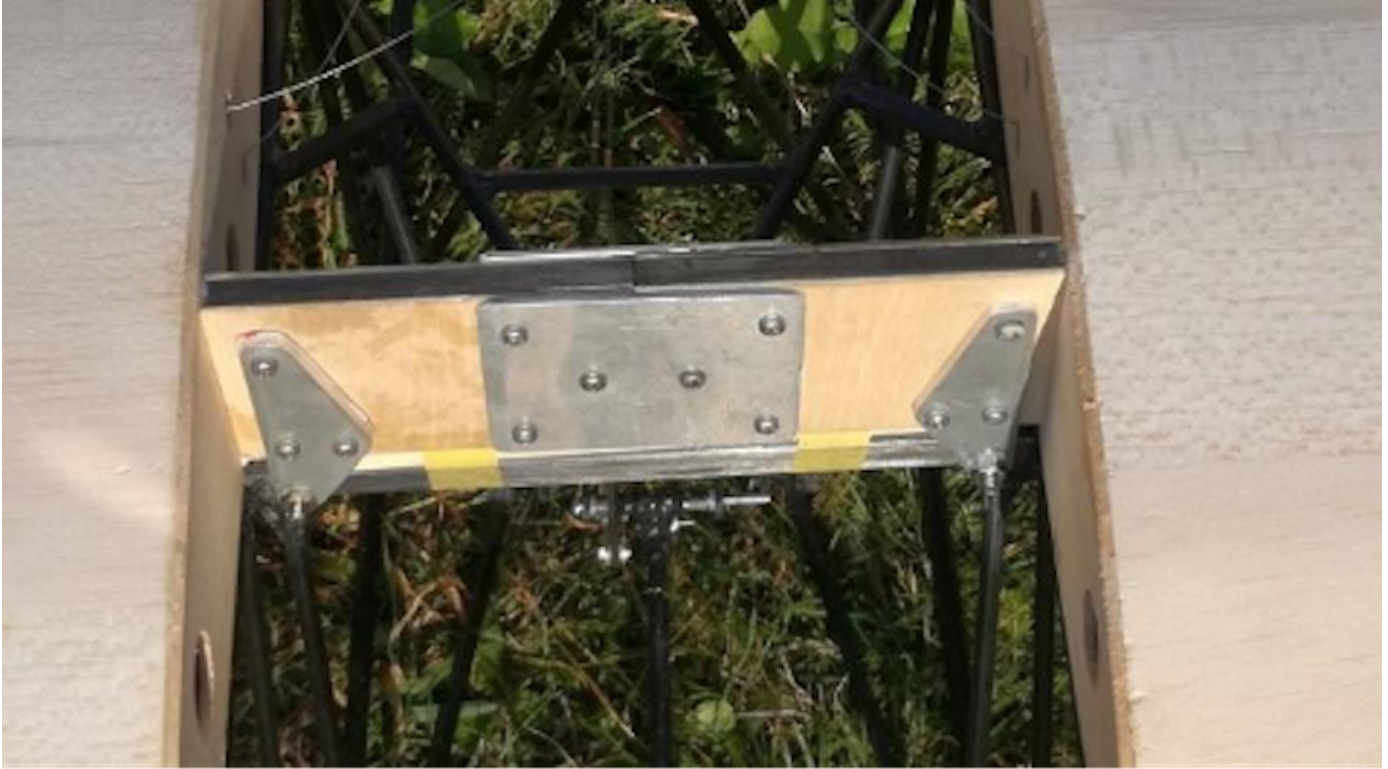
Photo 97: Fuselage joint test: left, front side; right, rear side.

Actually, it was a little difficult to reach this state after making the fittings. At first, I measured the squareness of the main wing and fuselage with the front side fittings. I stretched a string between the wing tip and the end of the

fuselage and compared the length of the string between the right and left sides. The result showed that the right side string was about 13mm longer than that on the left side. This means the main wing is attached to the fuselage slightly yawed to the left.

The reason for this is that the crossbeam on the fuselage to which the front spar is attached is slightly yawed to the left of the aircraft center axis. In fact, it was extremely difficult to secure the right angle of this beam when installing it. The fuselage is tapered backward, so it is difficult to find the center axis of the fuselage. The drawing showing the center axis of the fuselage is pasted on the bottom of the fuselage assembly jig, but there is a space of 200mm between the drawing and the crossbeam. This is the reason why the cross beam was attached at a slight angle. To correct this problem, 0.5mm shim was inserted between the front right side fitting and the center wing spar web. As a result, the main wing is now attached to the fuselage at right angles.

Next, I installed the rear fittings with the front fittings in place. The left side fit perfectly, but the space between the right side fitting and the rear spar web opened up by about 0.5mm. This was due to the shim inserted in the front fitting. I had no choice but to insert 0.5 mm shim here as well.

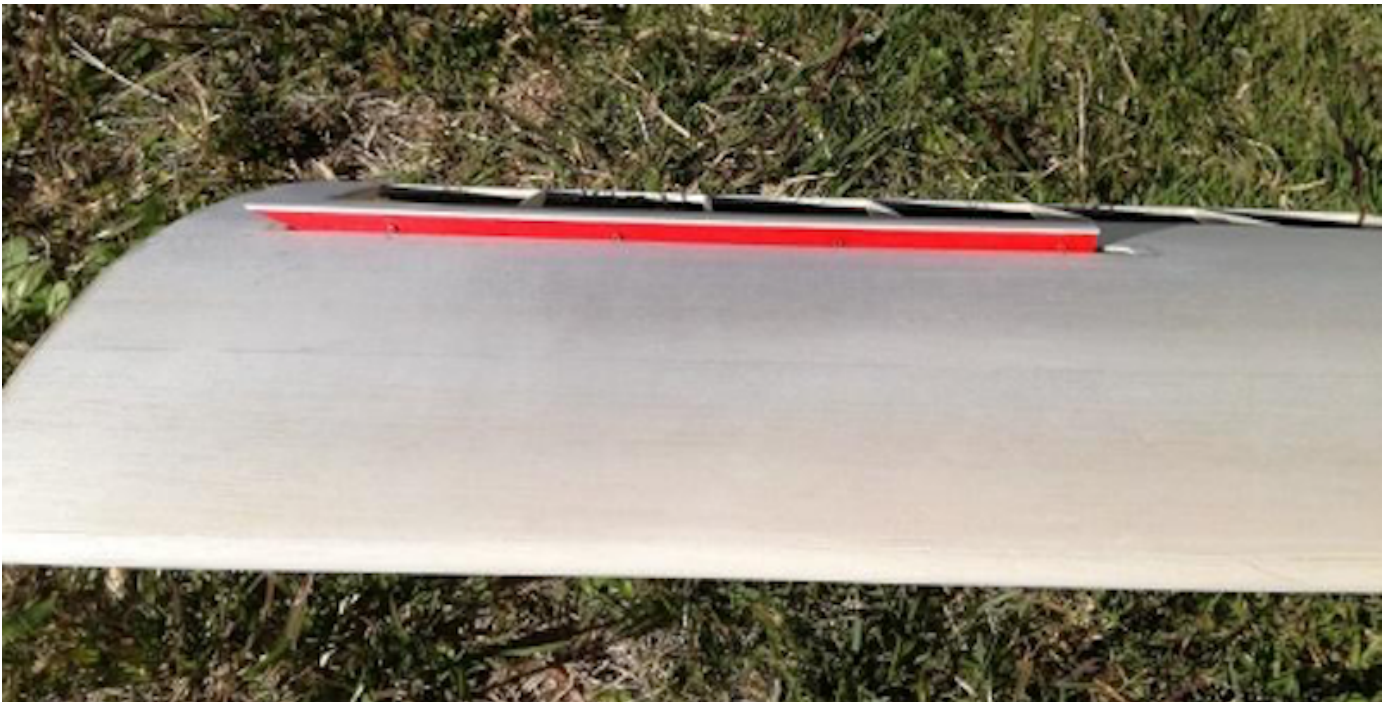
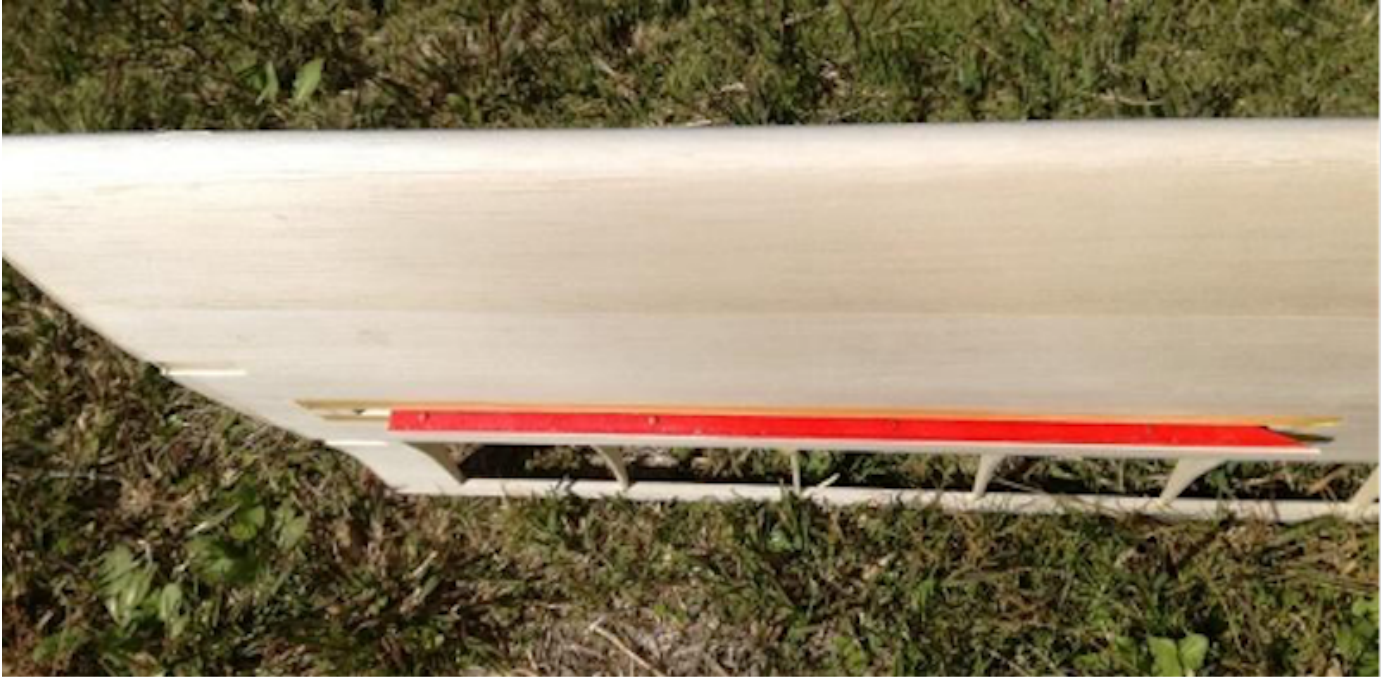
Photo 101: Checking the spoiler open state: left, upper side; right, lower side.

Next, I turned the knob of the servo tester in the opposite direction to check the spoiler opening status.

At this point, I thought it worked well, but in fact, the amount of spoiler protrusion was too small, as described in Mistake 3.

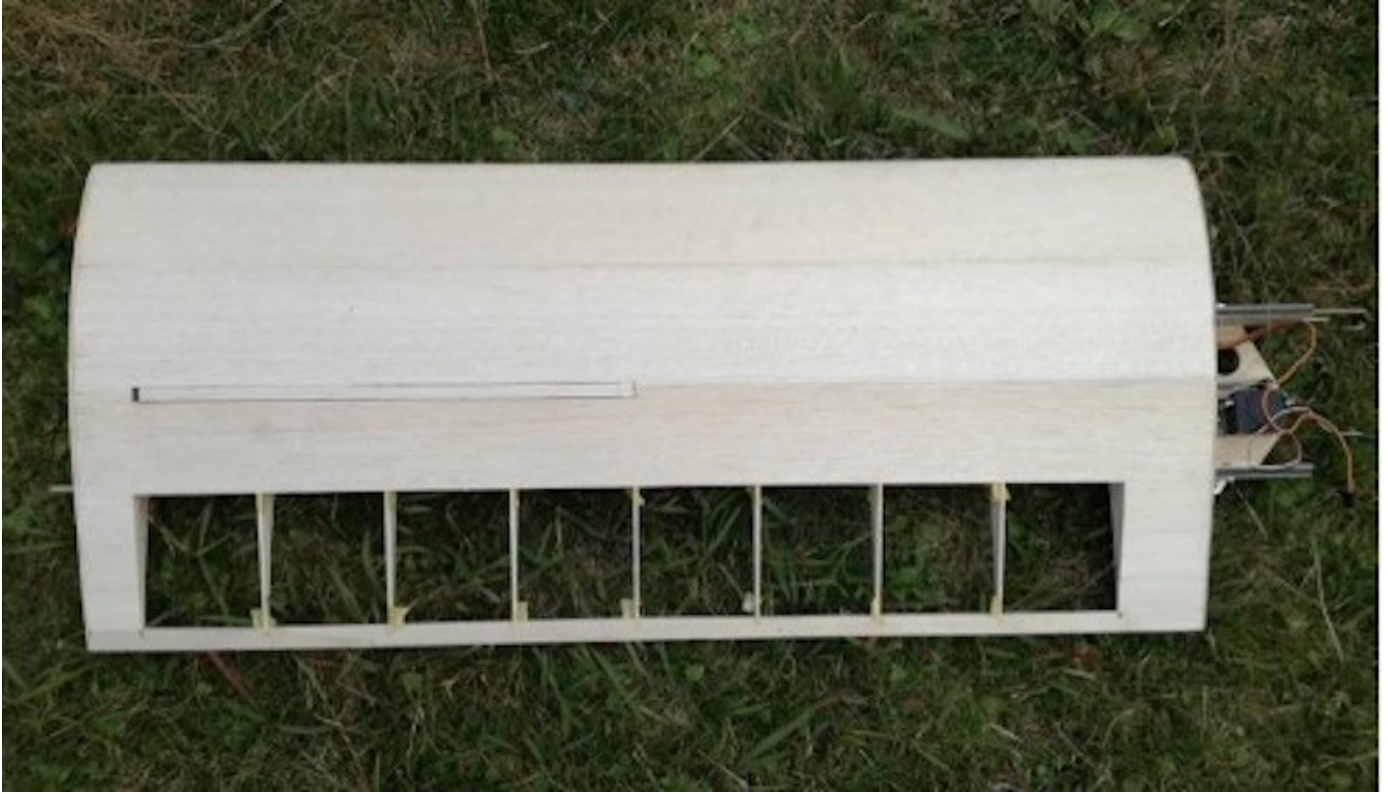
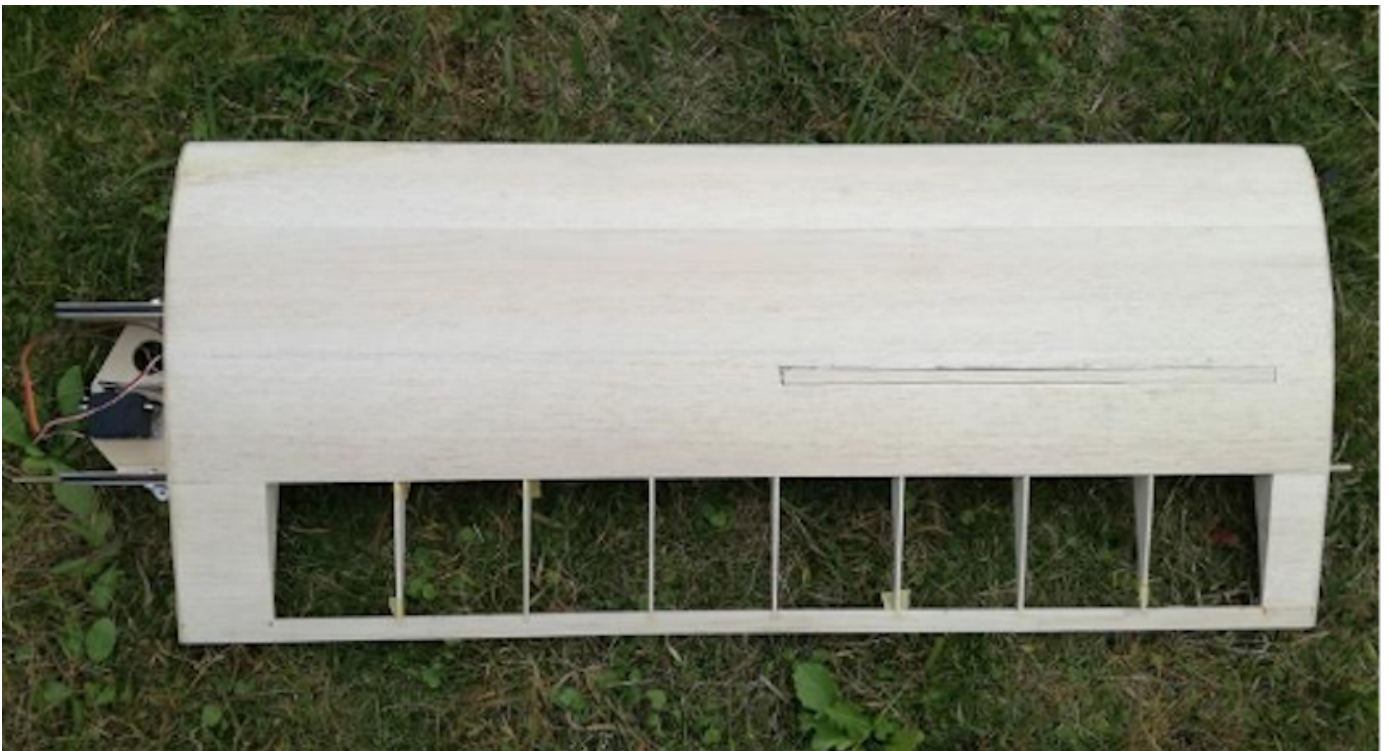
Photo 102: Finished center wing.

The left side is 717g and the right side is 737g. The right side is 20g heavier than the left. This is probably due to the weight variation of the plank material and the difference in the amount of epoxy adhesive used, which was applied in

large quantities around the aluminum tube of the wing connecting pipe receiver.

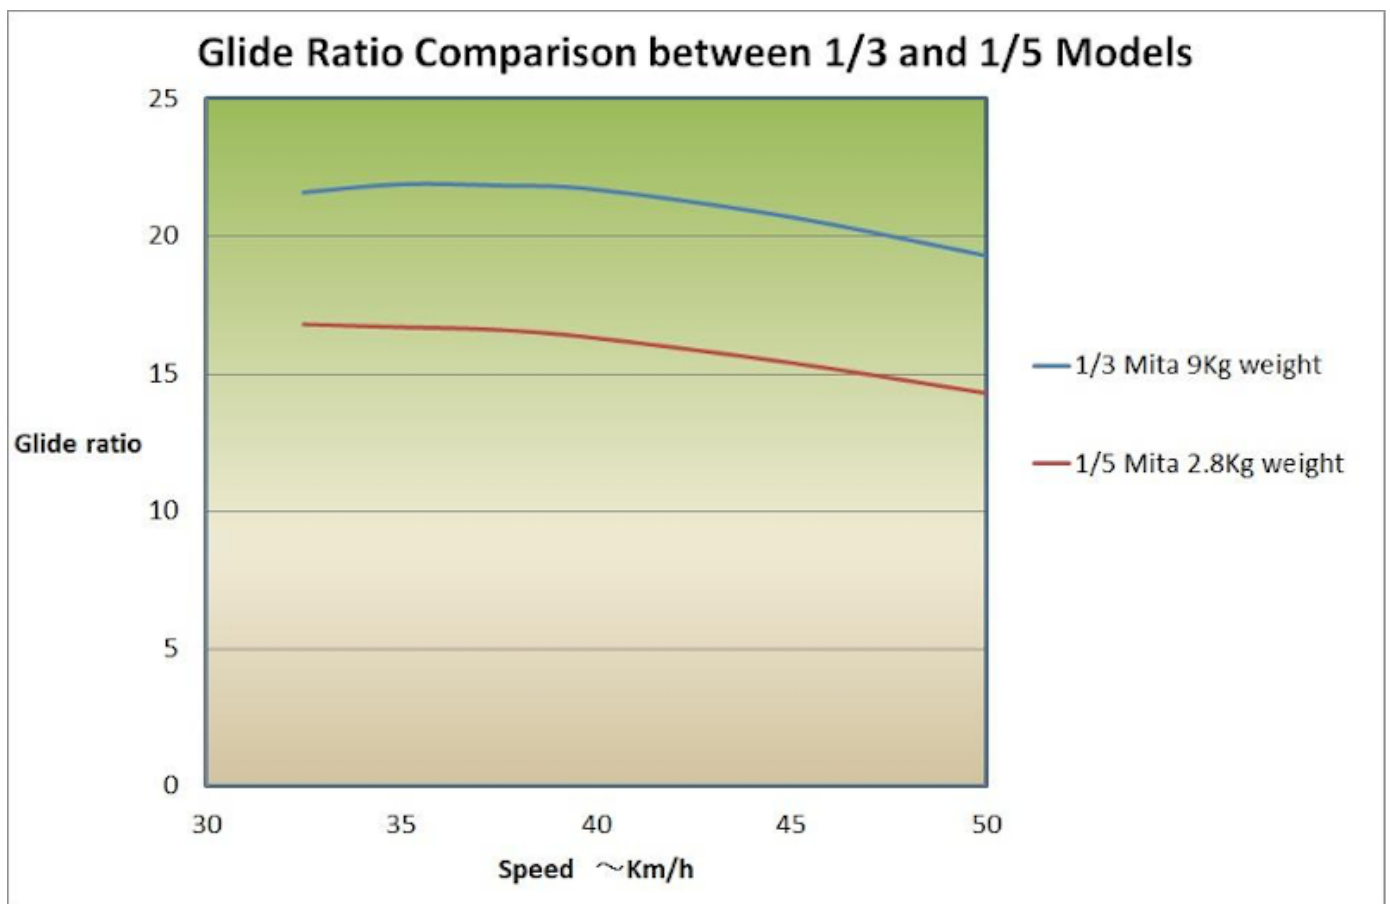
Graph 12: Comparison of glide ratio between 1/3 and 1/5.

Here is a comparison of glide ratios: 1/5 weighs about 2.8 kg, 1/3 weighs 9 kg. The best glide ratio of the 1/5 is only about 17. I am not so dissatisfied with this glide ratio, but the 1/3 is expected to improve it by about 30%.

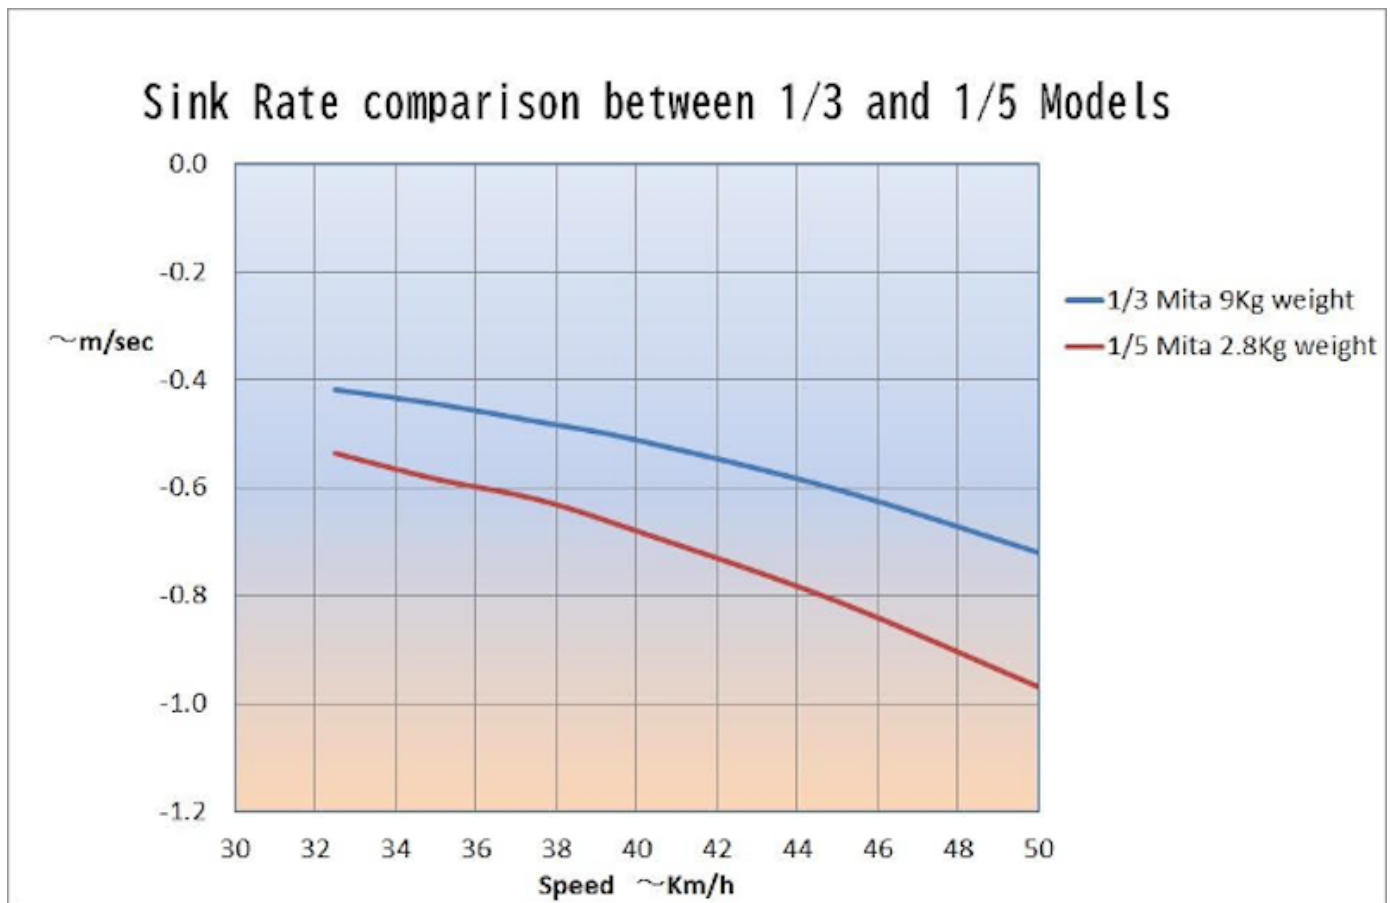
Graph 13: Comparison of the sink rate between 1/3 and 1/5.

The reason for these performance differences is the difference in the aerodynamic characteristics of the main wings due to the difference in Reynolds number between 1/3 and 1/5. Following graph compares the airfoils lift and drag coefficients of the two aircrafts at a flight speed of 35 km/h.
