1/3rd Scale Mita Type 3 Production Notes

The fifth part of a multi-part series.

Fabrication Part 16: Elevator Control System

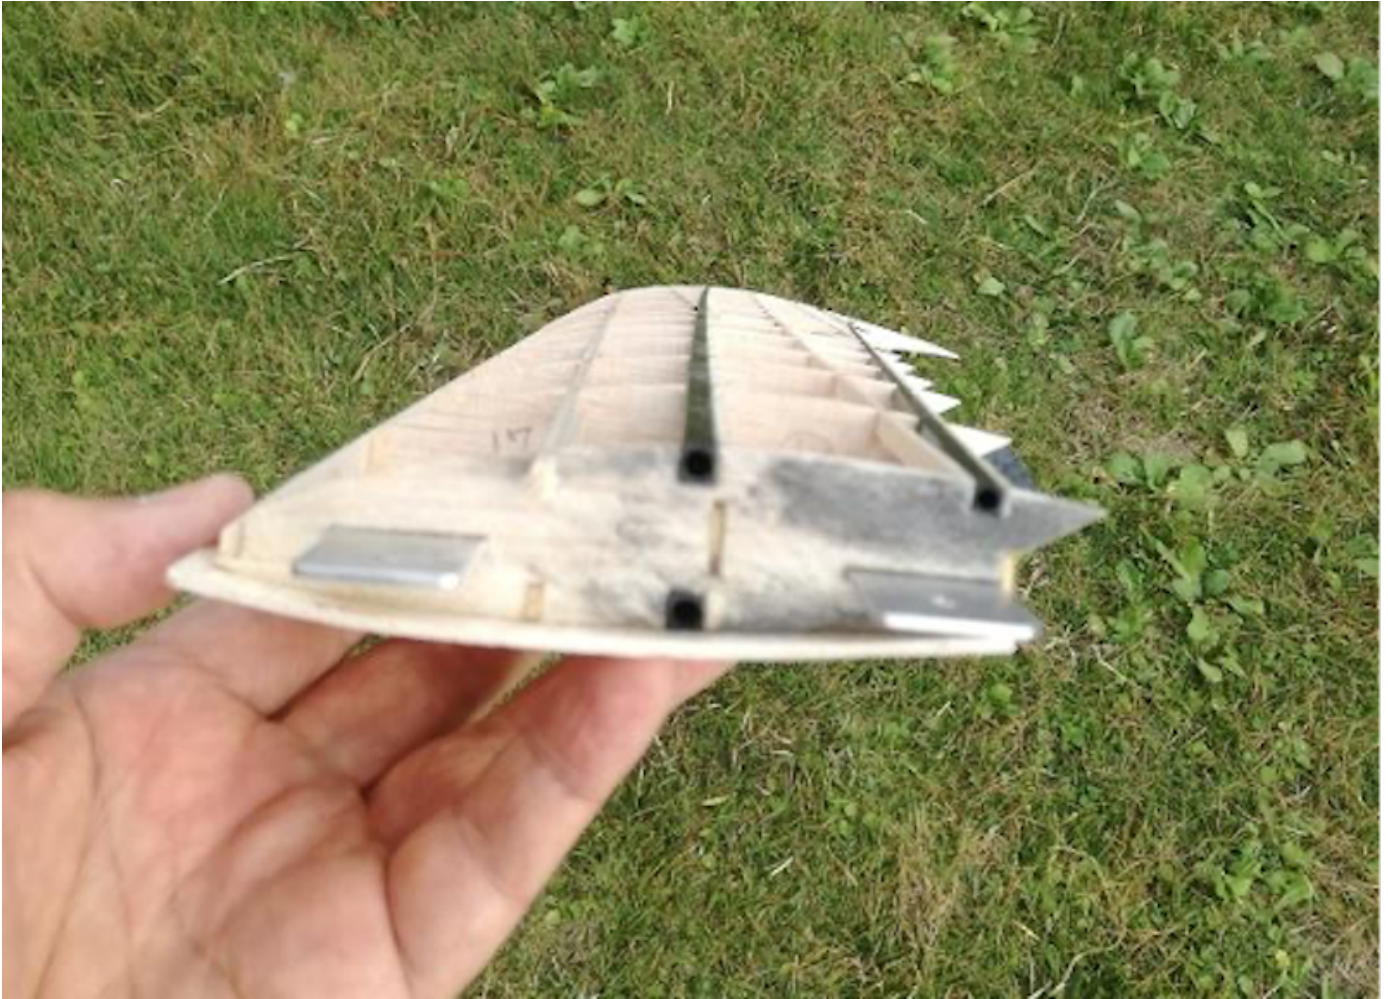
Image 103: Deformation of the outer wing spar.

attention to the deformation of the jig. When the lower surface planking was completed, I looked through the spar from the side and found that the carbon spar flanges, which should be straight, were slightly curved!

The photo 49 (June issue) taken when the rib assembly was completed showed the spar went straight through. I regretted that I should have checked more carefully before dropping the CA, but it was too late. There was no way to fix it. It was a painful mistake.

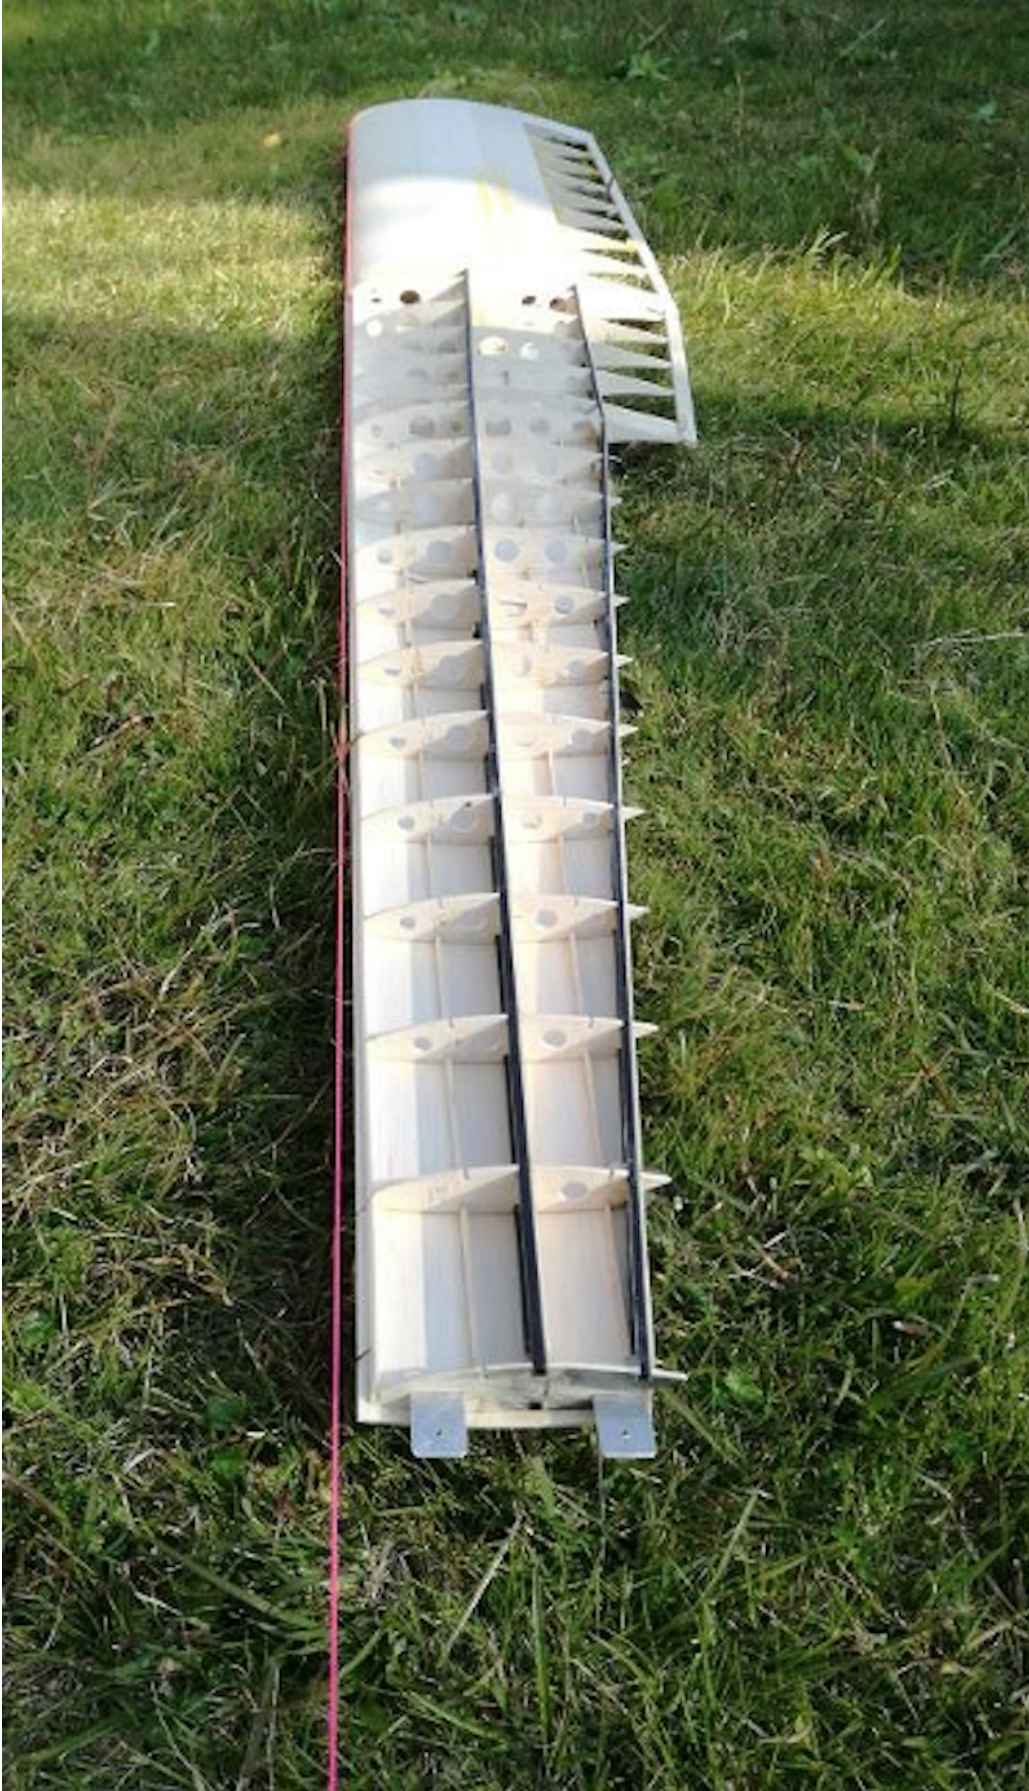
After regaining my composure, I checked the effect of the bent spar in connection with the center wing (photo 104).

Normally, the leading edges of the center wing and the outer wing are in a straight line, but the leading edge of this outer wing has a swept back angle of about 0.57° . This is a big mistake for a scale aircraft, but the saving grace is that the outer wing has an dihedral angle, so its leading edge appears to be slightly swept back in most cases. This can also be seen in my 1/5 model (photo 105) where the leading edge was made straight through. Therefore, I decided to leave the wing as it is because it will be almost indistinguishable in appearance and this degree of retraction will have little effect on the flight characteristics.

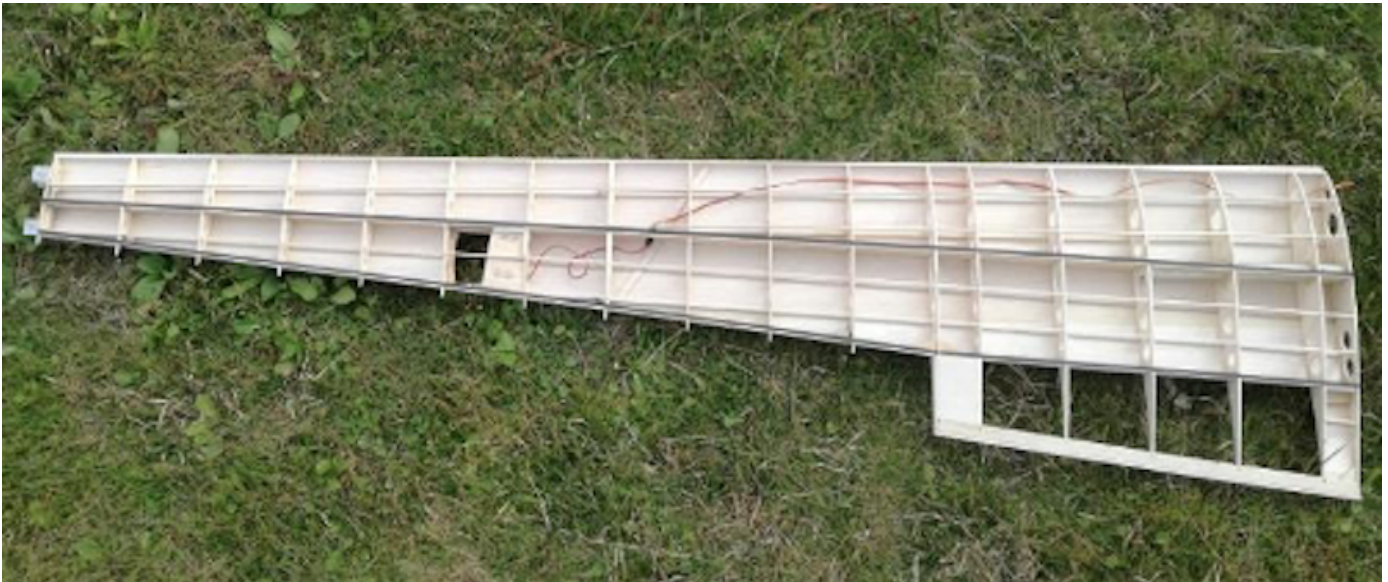
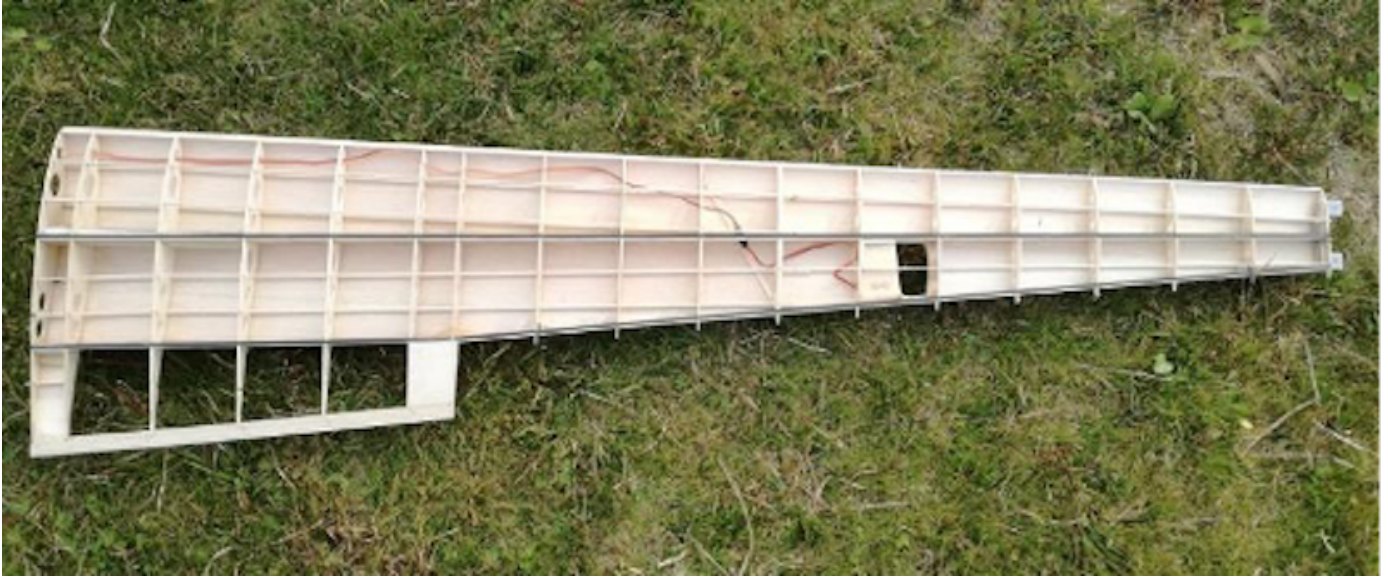
Photo 106: The outer wings with the lower plank completed.

After a lot of hard work, I managed to fix the hinge positions, installed the aileron servos, and positioned the upper stringers in preparation for the upper surface planking.

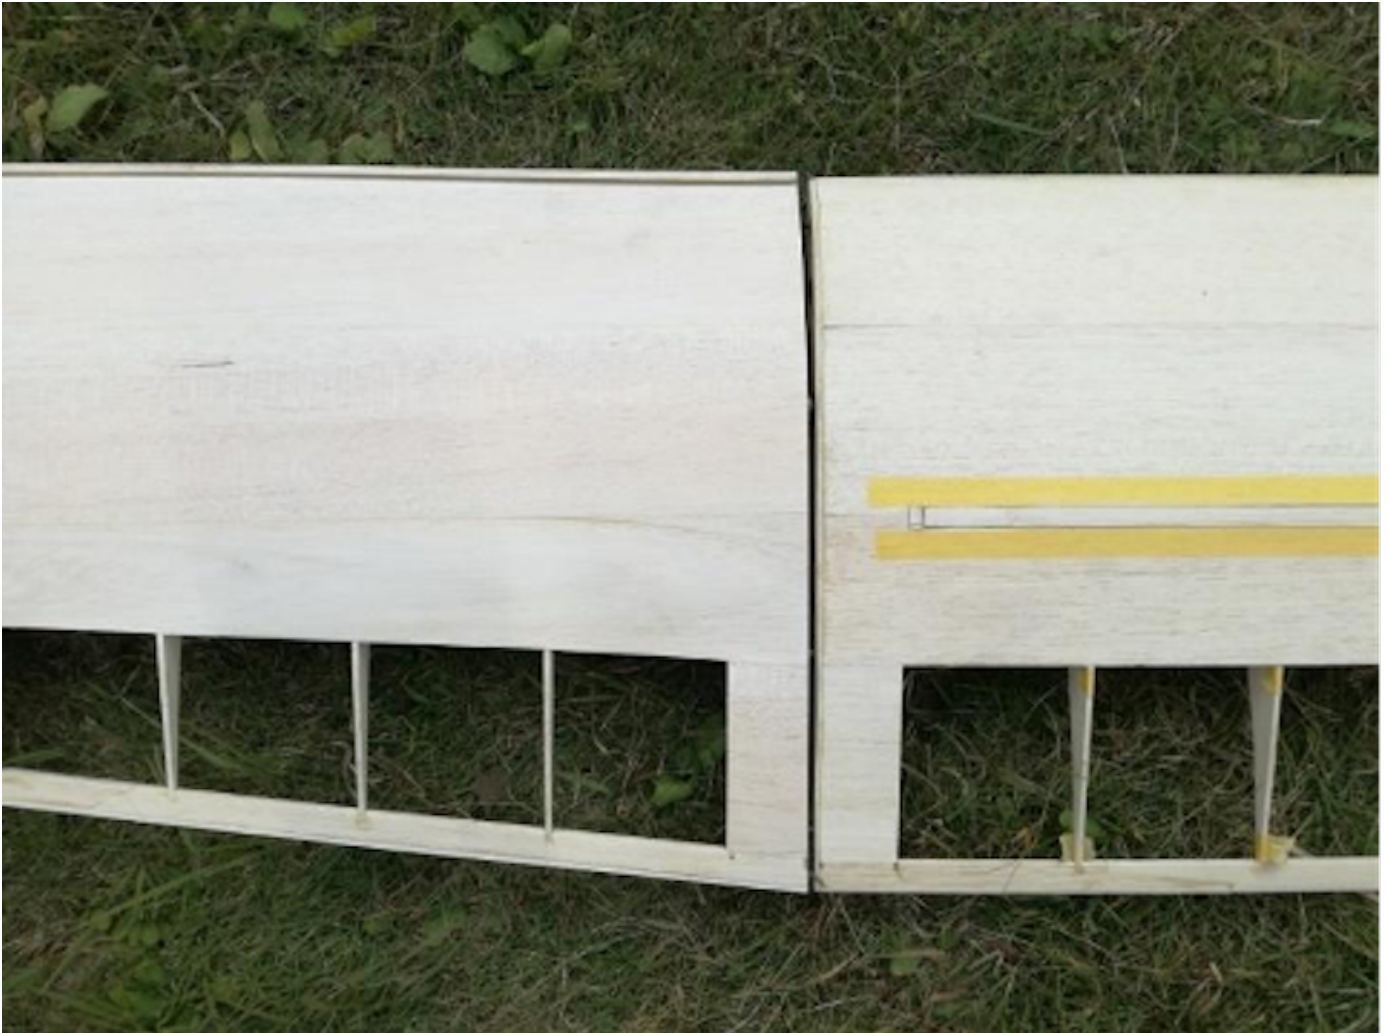
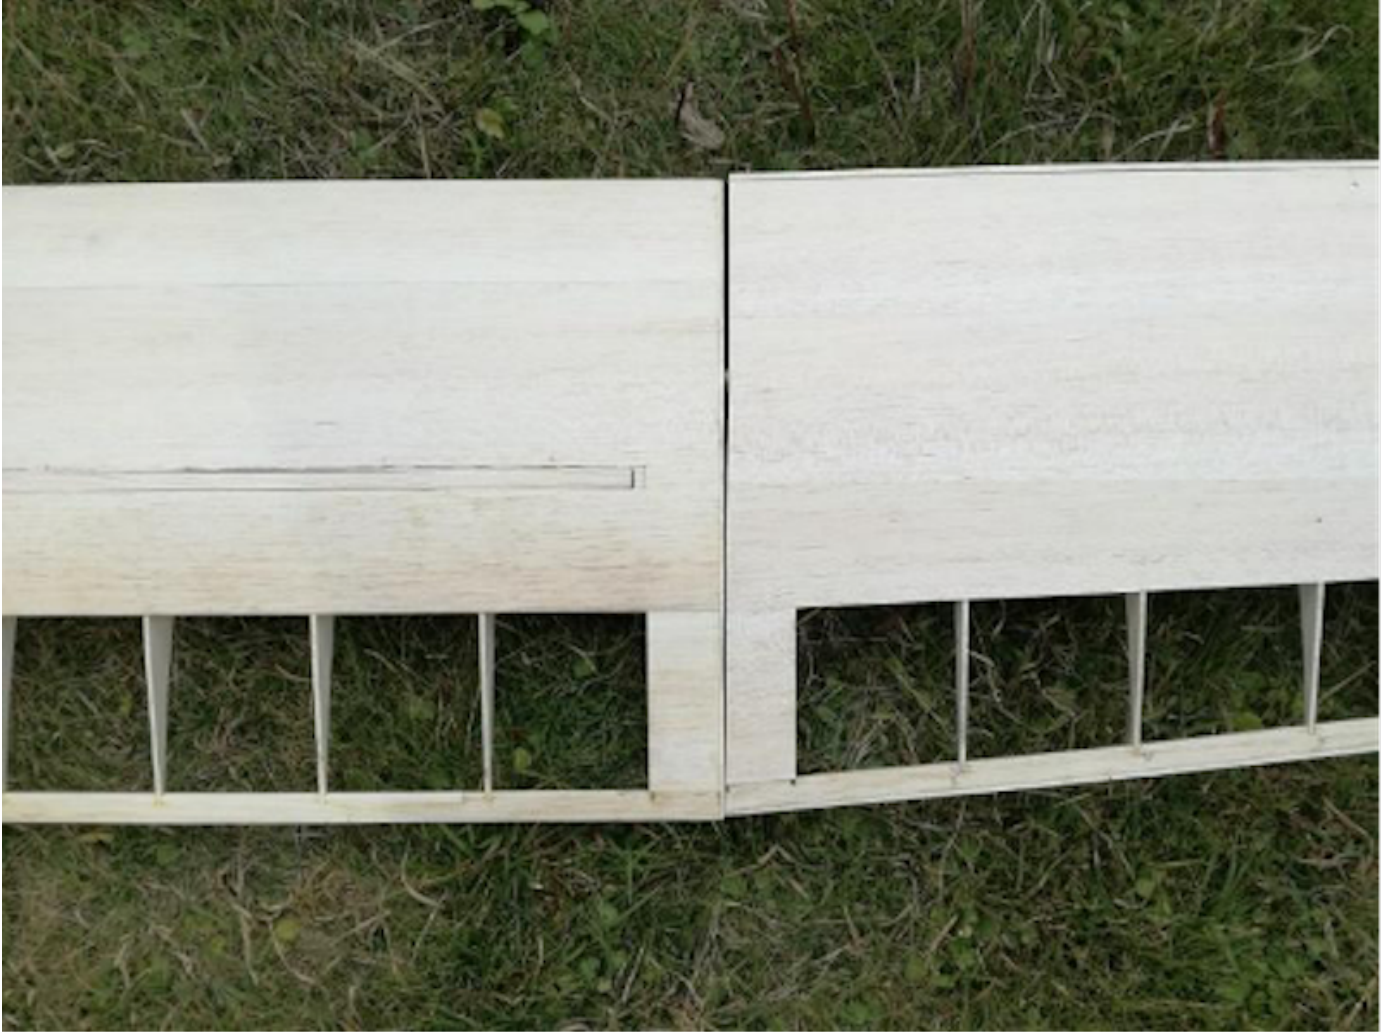
Photo 107: The connecting surfaces of the center wing and the outer wing do not meet!

The work went smoothly up to this point, but when I connected the outer wings to the center wing, I found an unexpected problem. As the leading edge of the outer wing has a swept back angle of 0.57° , its effect appeared as the innermost rib of the outer wing was not parallel to the

outermost rib of the center wing. There is about a 4 mm gap between the two wing's leading edges.

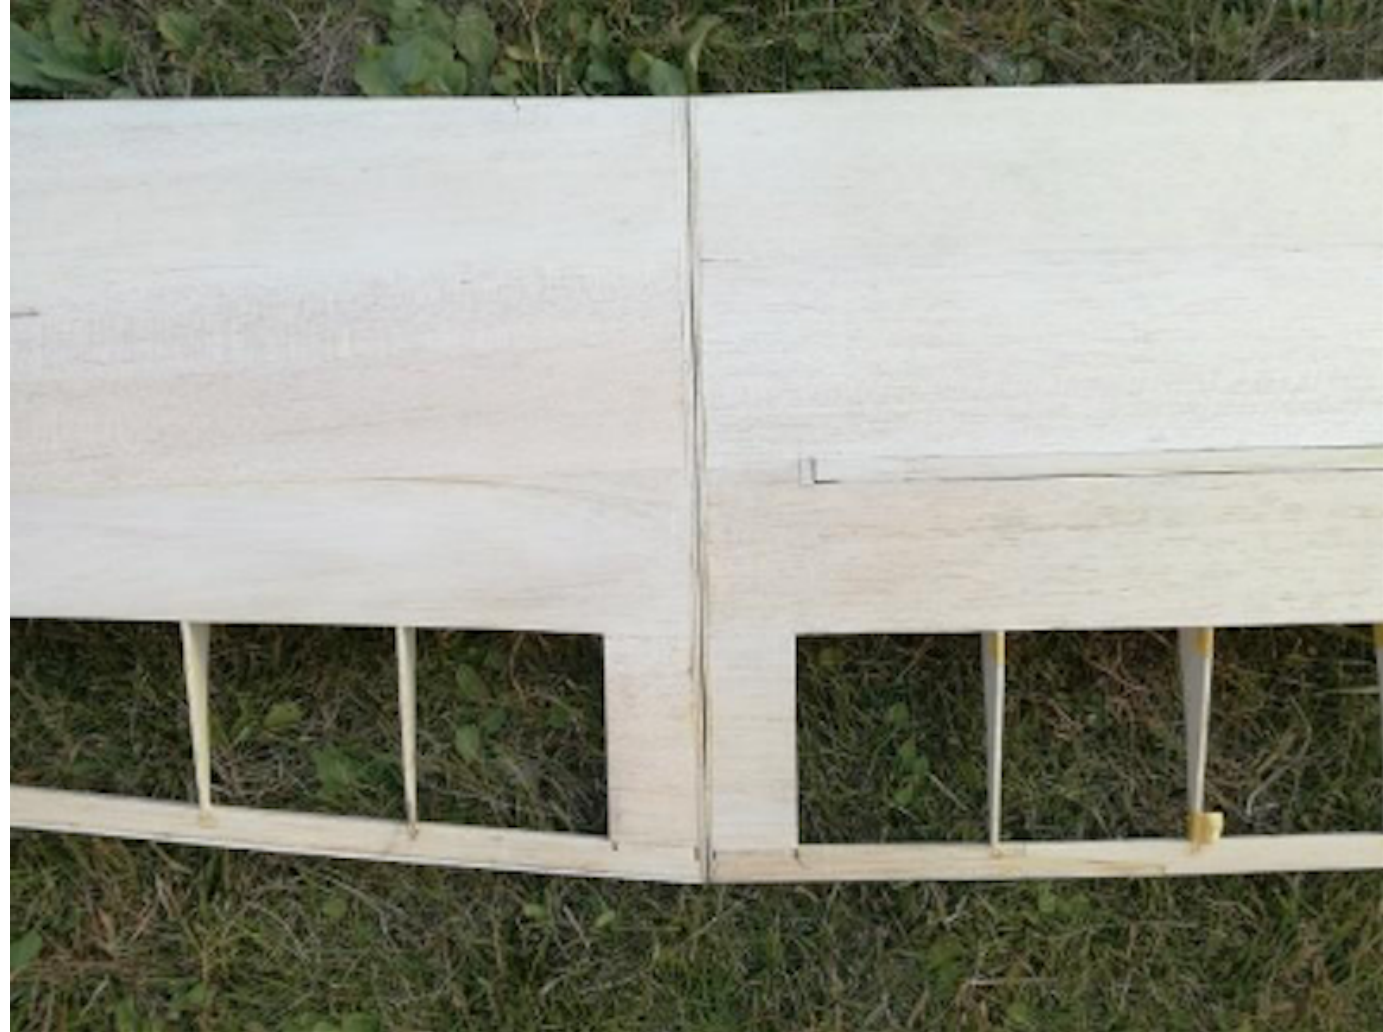
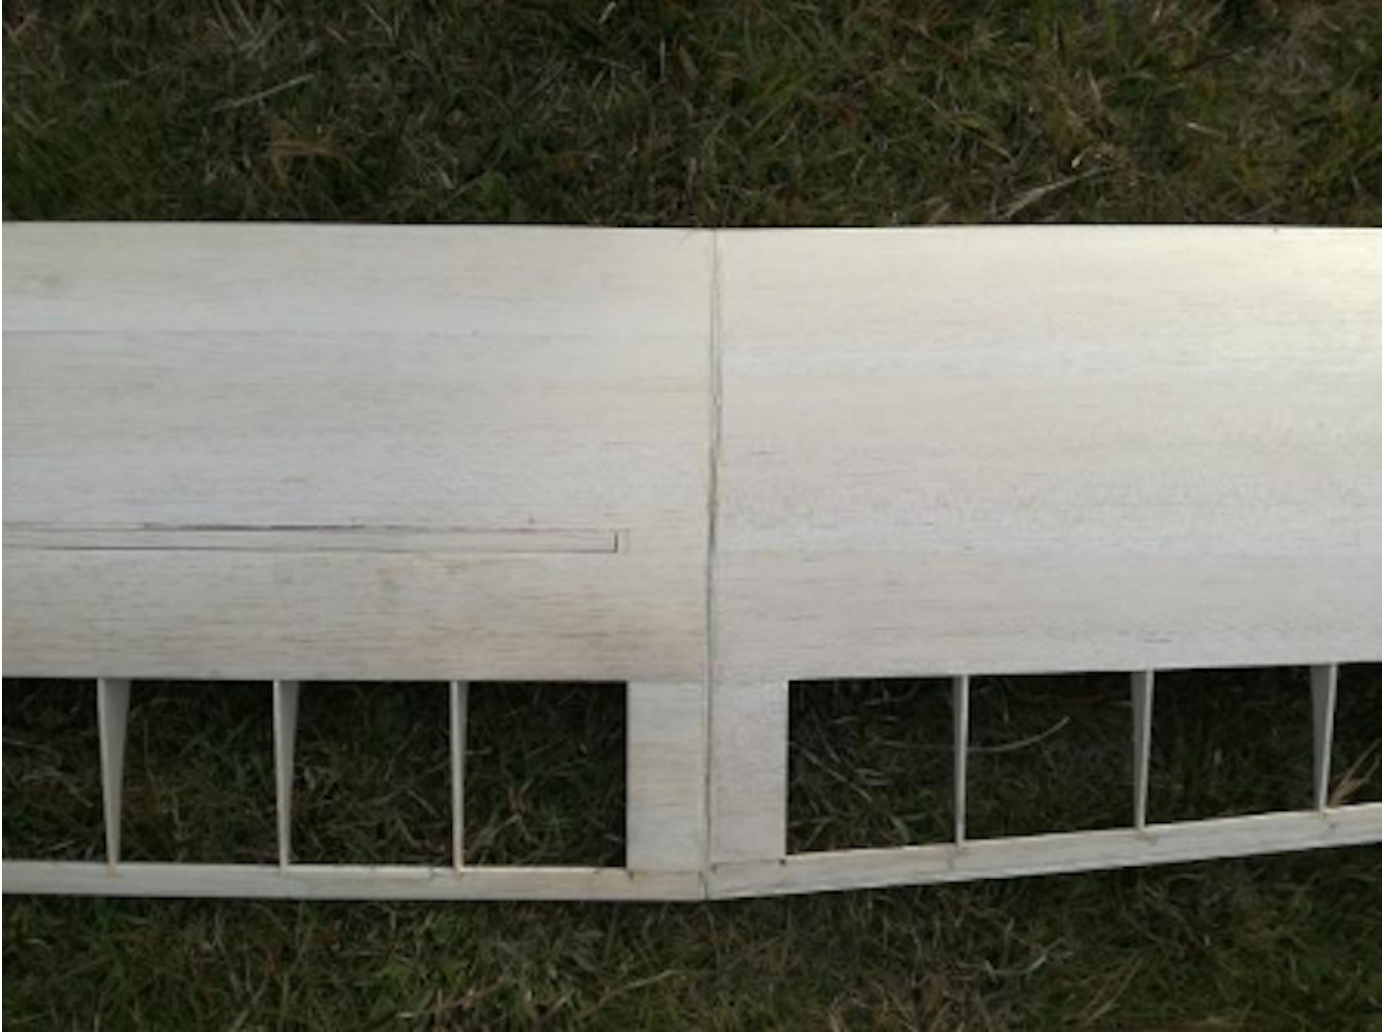
Photo 108: The revised connecting surfaces.

This was not acceptable and I had to fix it, but since the outer wing has a dihedral angle, it was a little difficult to fill the gap. I attached two pieces of 2mm balsa sheets in a staircase shape on the innermost ribs of the outer wings and then, by connecting them to the center wing, fixed it carefully with a file while checking the condition. At the same time, the leading edge was shaped to complete the wing shape.

I'm sure if a person who is good at crafting did it, the gap would be invisible, but with my skill, I have to accept this level of completion.

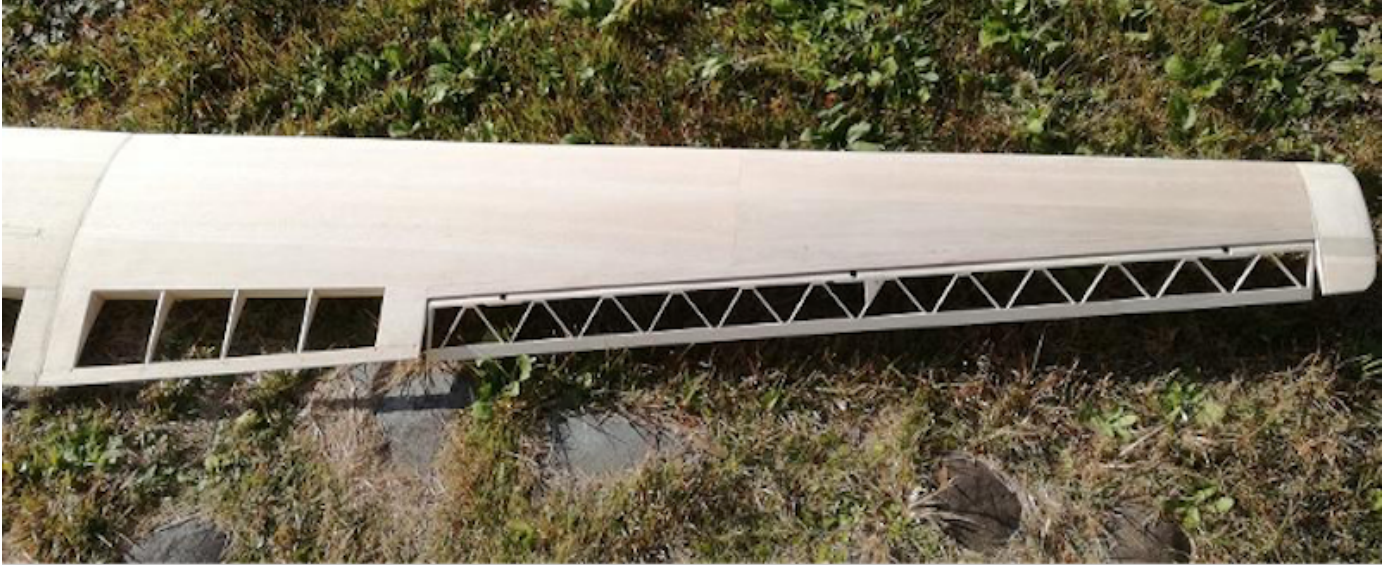
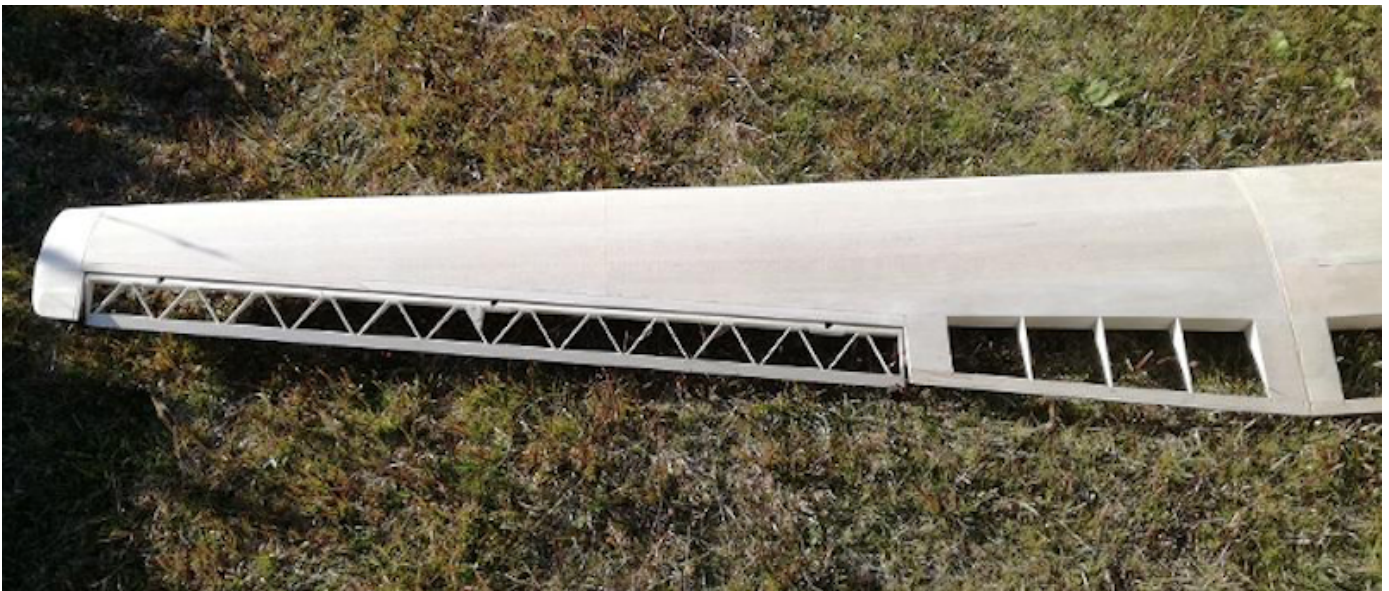
Photo 109: Finished outer wings.

After attaching the lip that covers the top of the leading edge of the aileron, the aileron was attached and the length of the lip was adjusted to secure the aileron operating range. Then, I attached the wingtips and shaped them so that the outer wing contour and wingtip are smoothly connected.

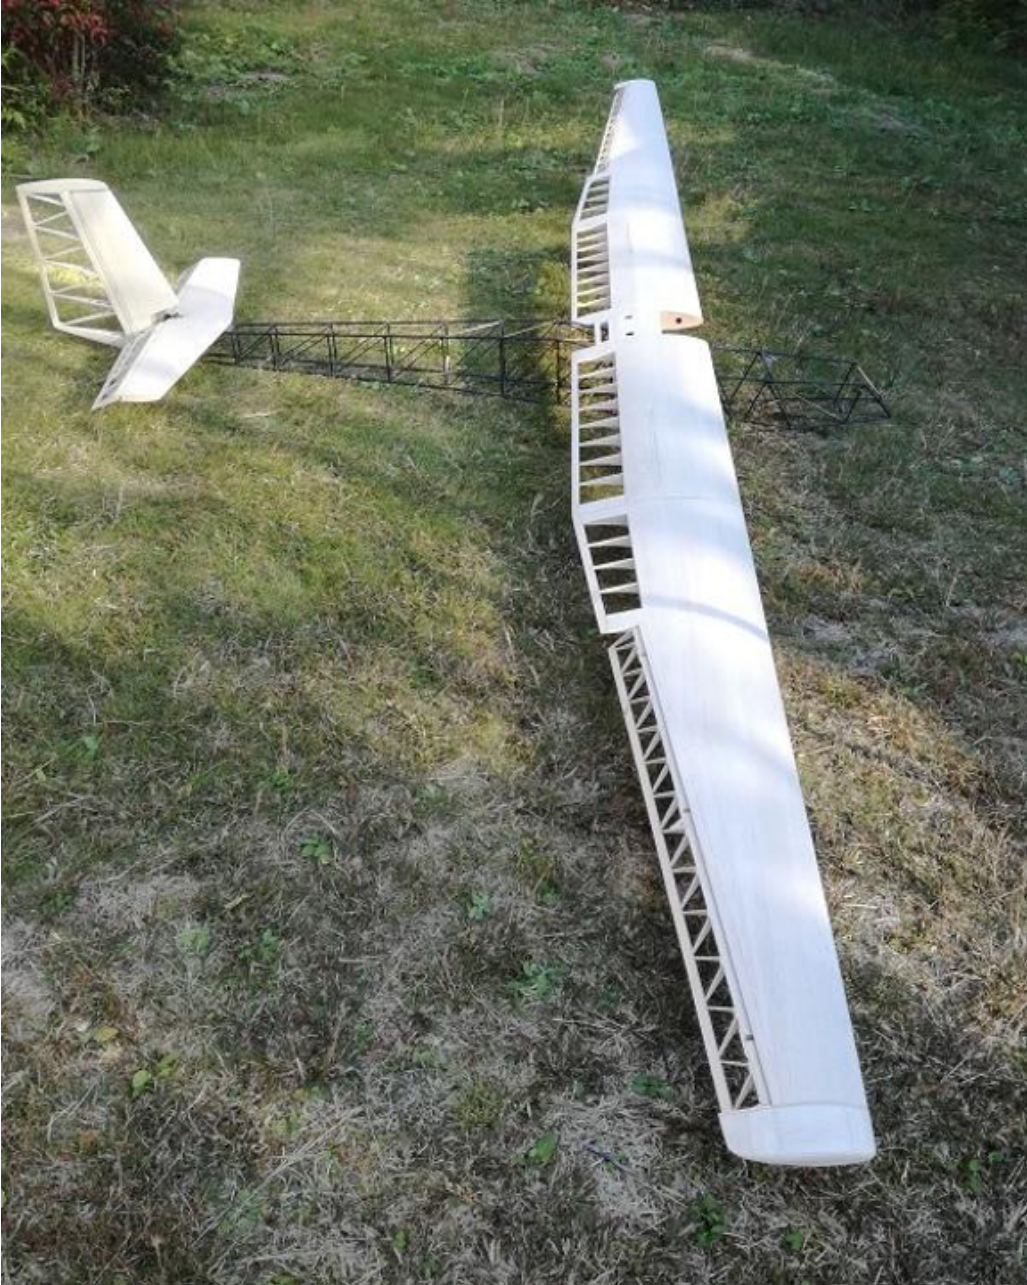
Photo 110: Main and tail wings assembled on the fuselage.

I connected the outer wings with the already completed center wing to make one main wing and put it on the fuselage with tail wings.
